AHERA 3-YEAR REINSPECTION REPORT

Montachusett Regional Vocational Technical School

1050 Westminster Street
Fitchburg, Massachusetts 01420

JANUARY 20, 2023

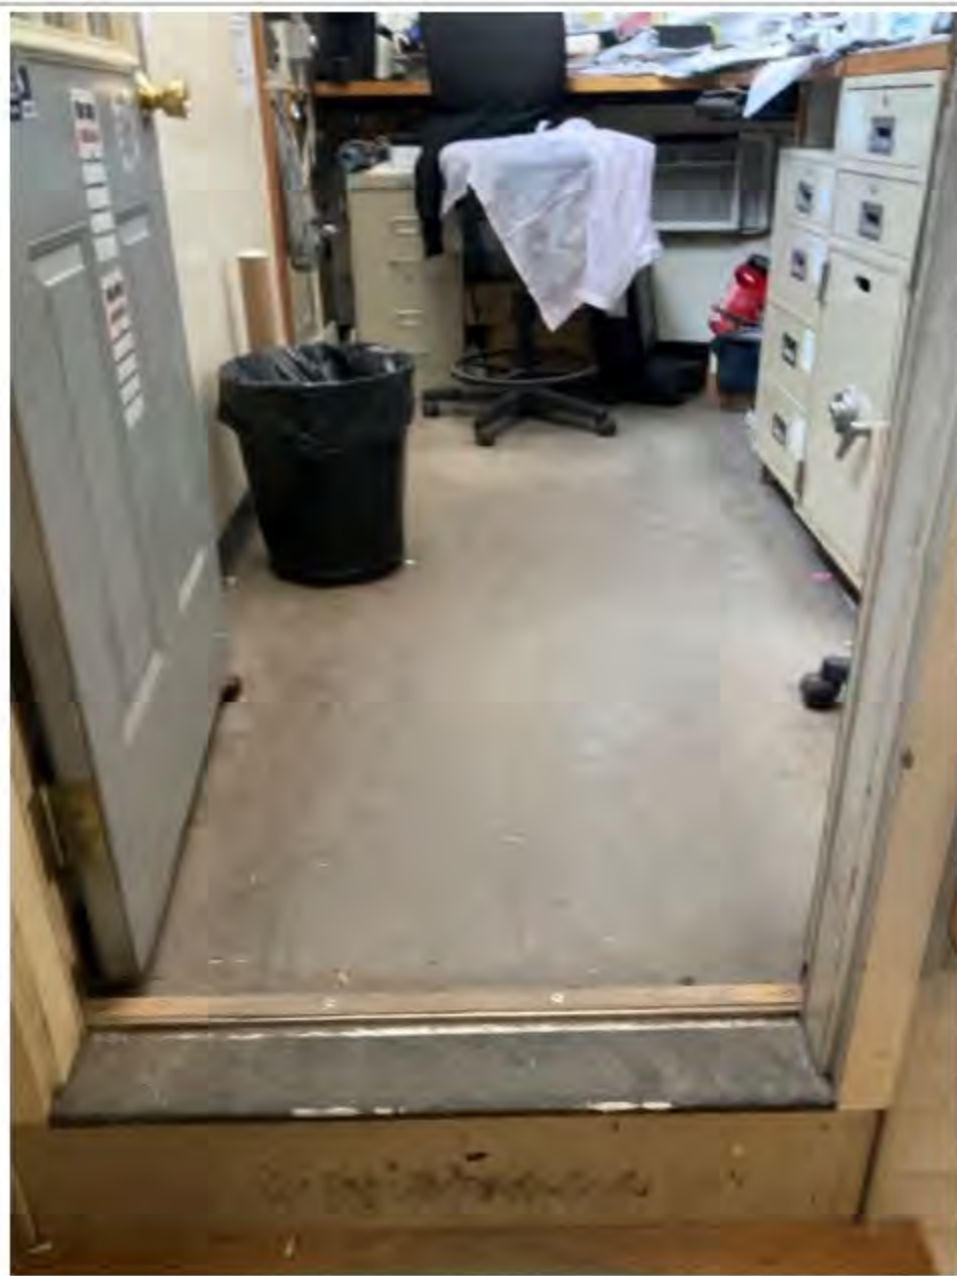
HA #1

12x12 Beige speck F.T.

Quantity 50SF-collision repair office

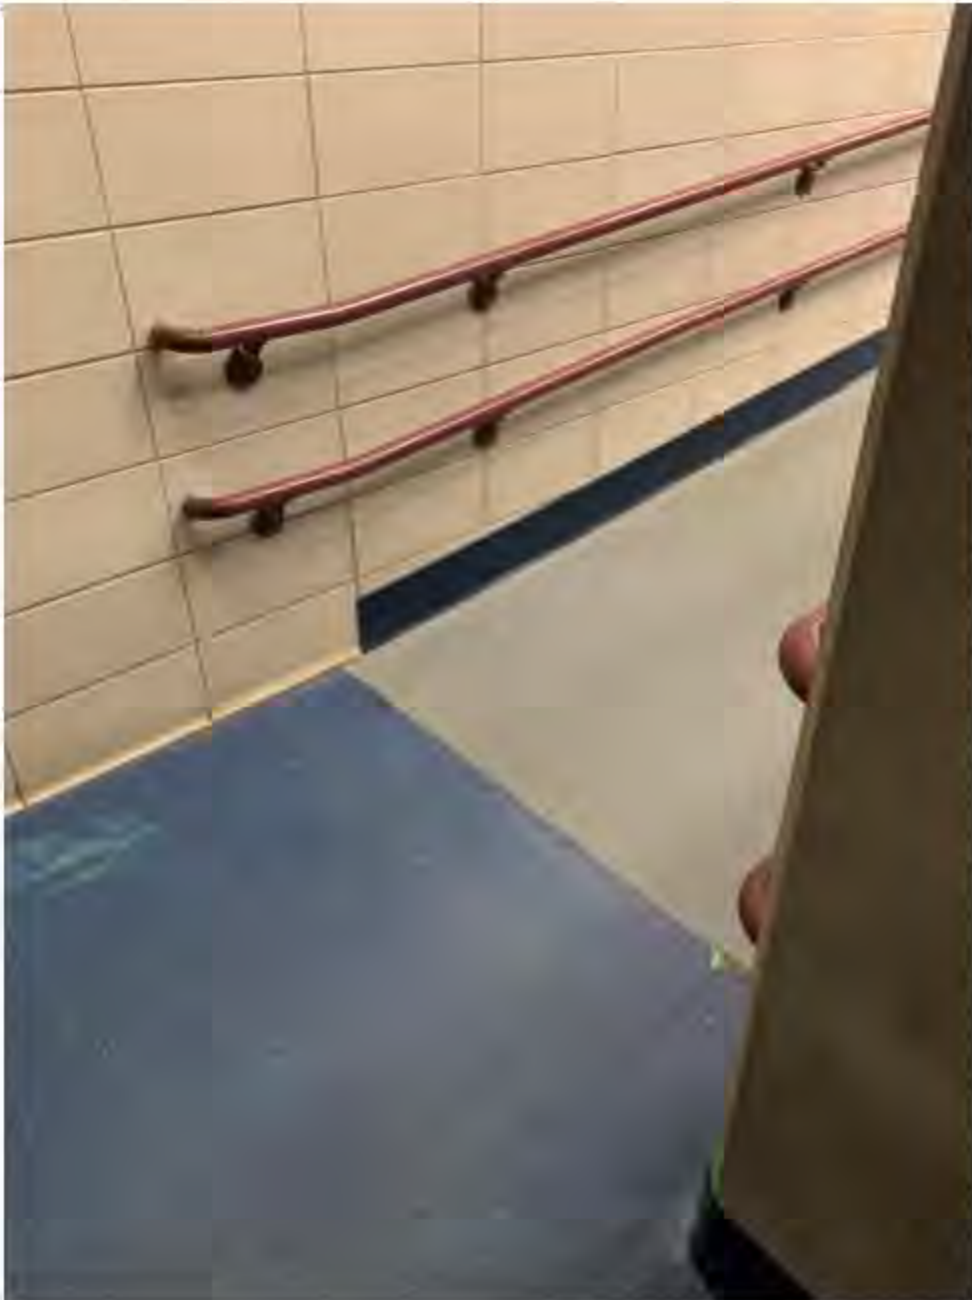
12x12 Blue FT

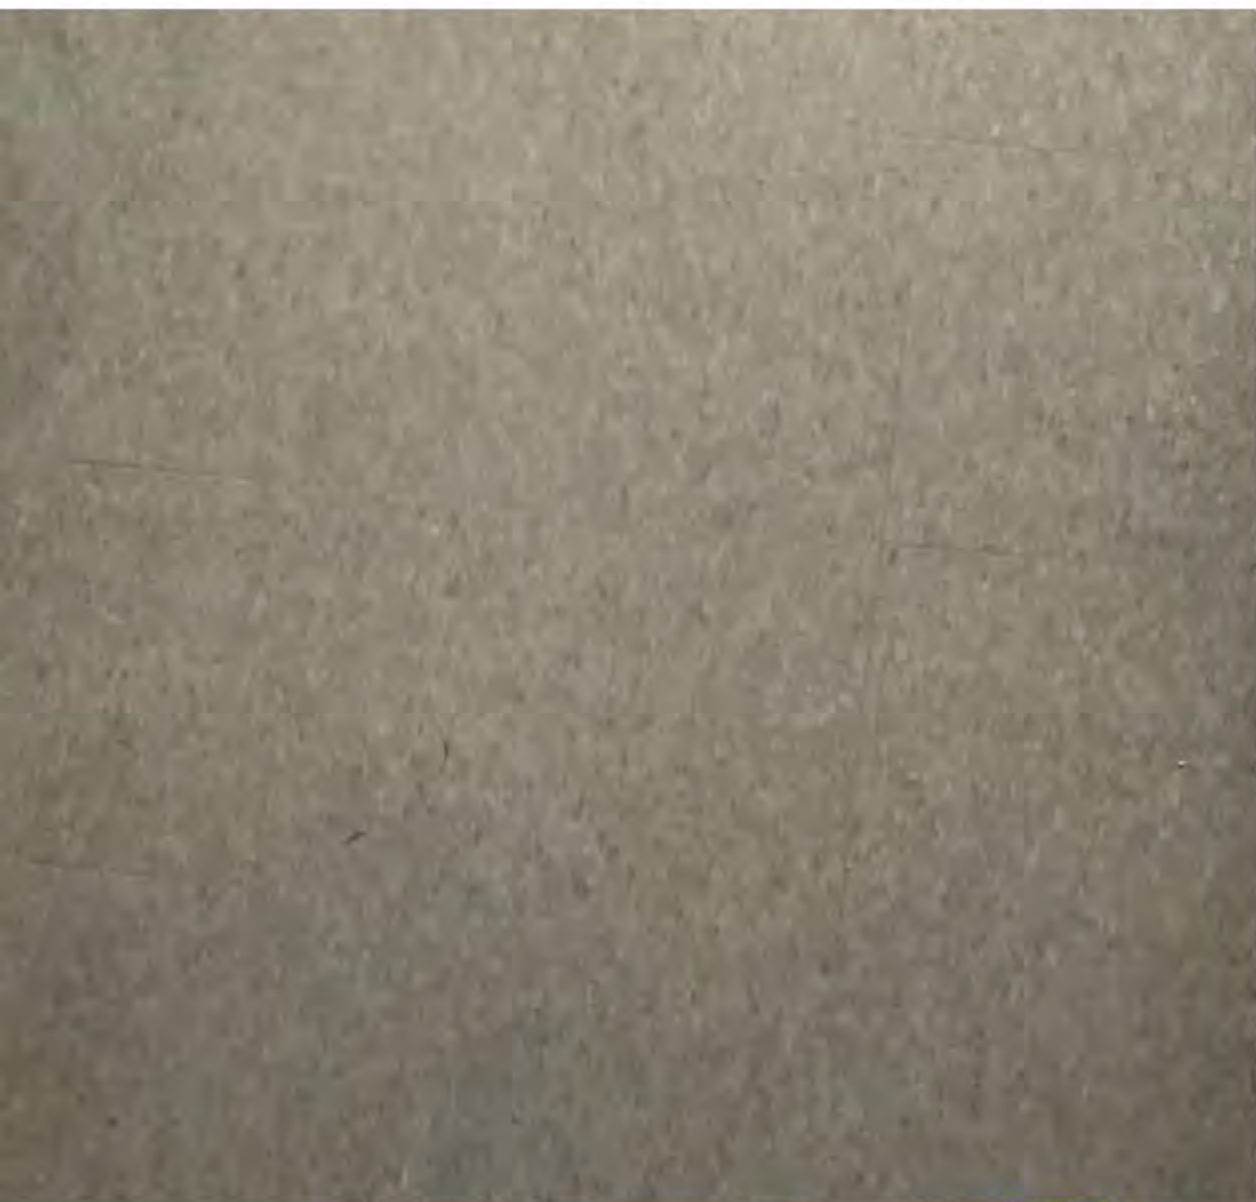
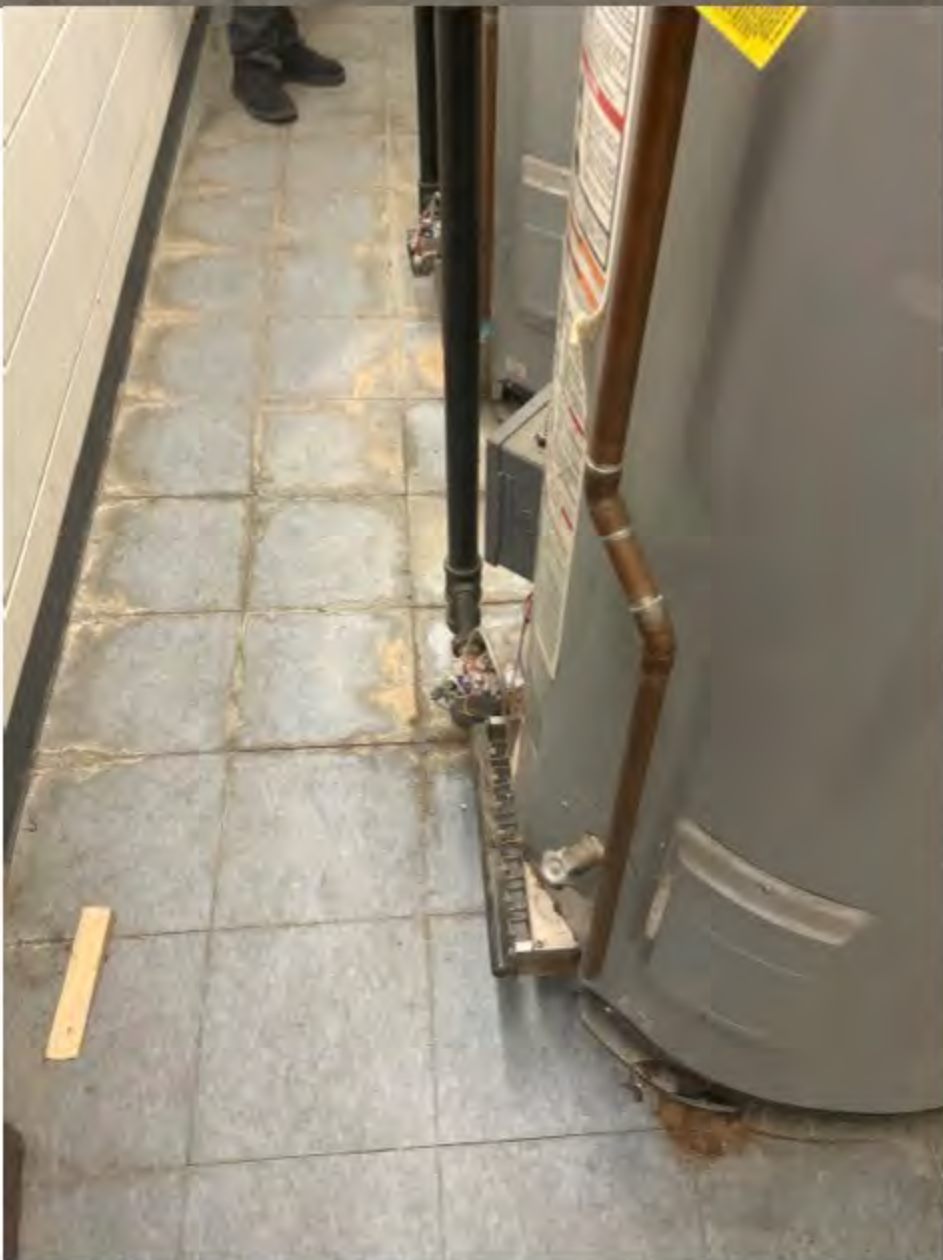
Type of Damage: Water
(e.g., flaking, blistering, water, physical, puncture, delamination, etc.)

Severity of Damage: Moderate
(e.g., minor, moderate, severe)

Extent of Damage: Limited to Sprinkler room, 140SF.

Known or Suspected Cause(s) of Damage: Water intrusion

12x12 Bluish Grey Speck F.T.

Quantity 1000SF-940. 1200sf-524 2000sf-engineering. Electrical closet by gym
75Sf-electrical closet by gym. 140sf-sprinkler control room (damaged)

Preventative measures to eliminate/prevent damage: Perform asbestos testing in The affected area to determine the need for asbestos abatement professionals to be involved in future steps, if materials are found to be positive, engage an abatement contractor to remove or repair the damaged floor tile in the sprinkler room. Check the status of the pipes throughout school to prevent any bursts or leaks in the future

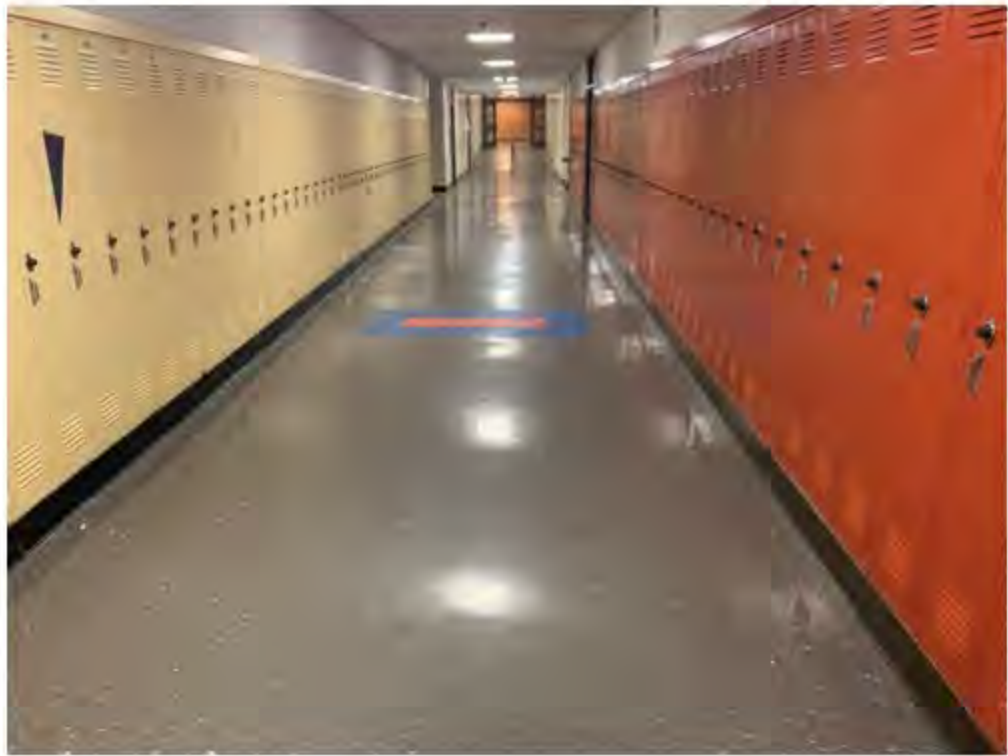
12x12 Dark Grey Speck F.T.

40000sf Through halls entrances

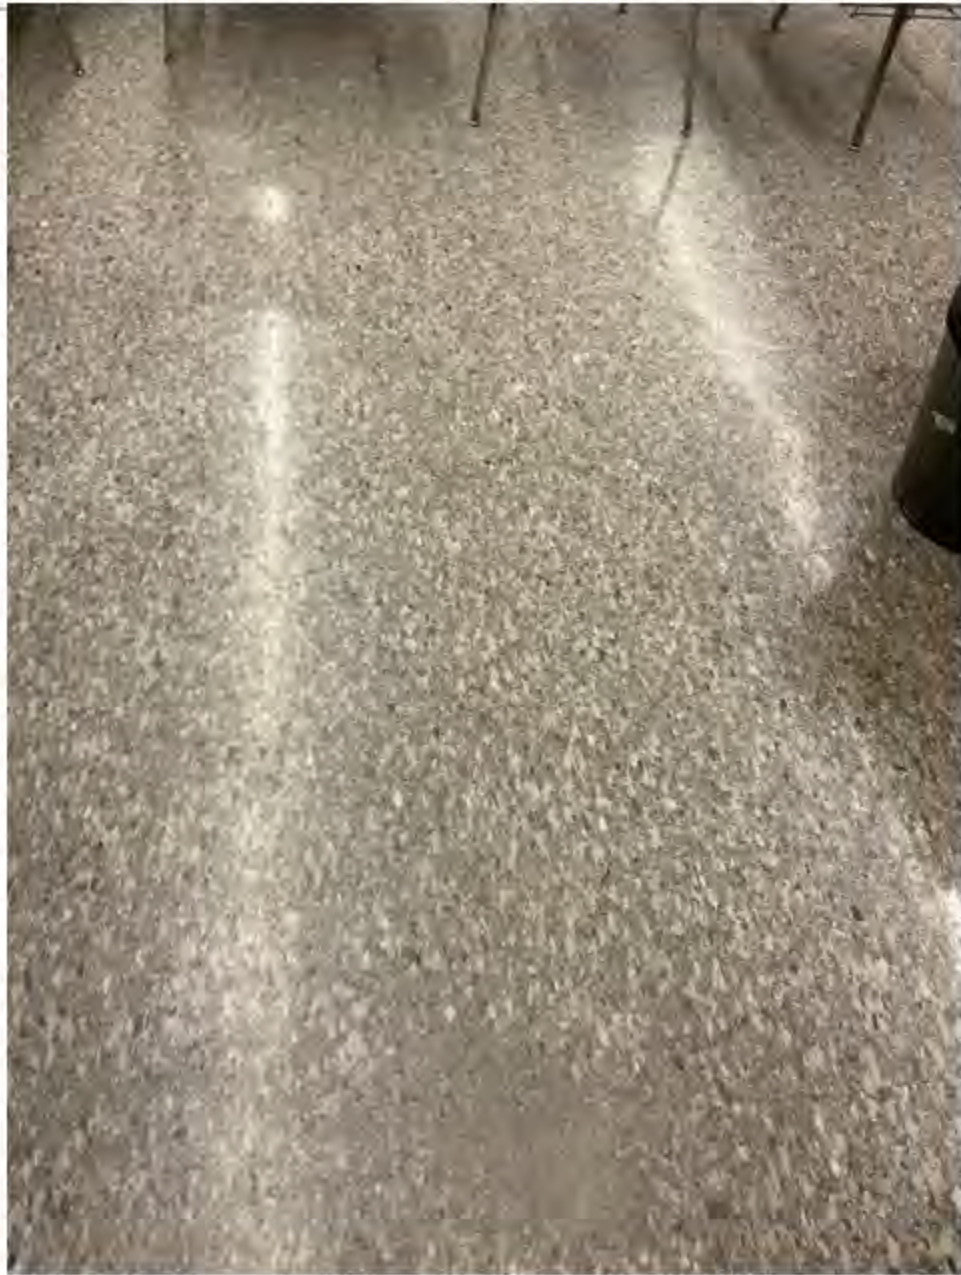
12x12 Grey/white Speck
Location
Quantity 400sf-419. (1970 2nd. floor Build Court Classrooms 600sf each) 8400SF total.
150SF-222 Office. (1970 1st floor build Courtyard classroom 6000sf)
1000sf-534 900sf-523 1000SF-732. 1000sf-725 1000sf-731 1000sf-730
900SF-culinary arts related. 900sf-672 900SF-671 900sf-682 Arm Lab
900SF-501 900sf-502

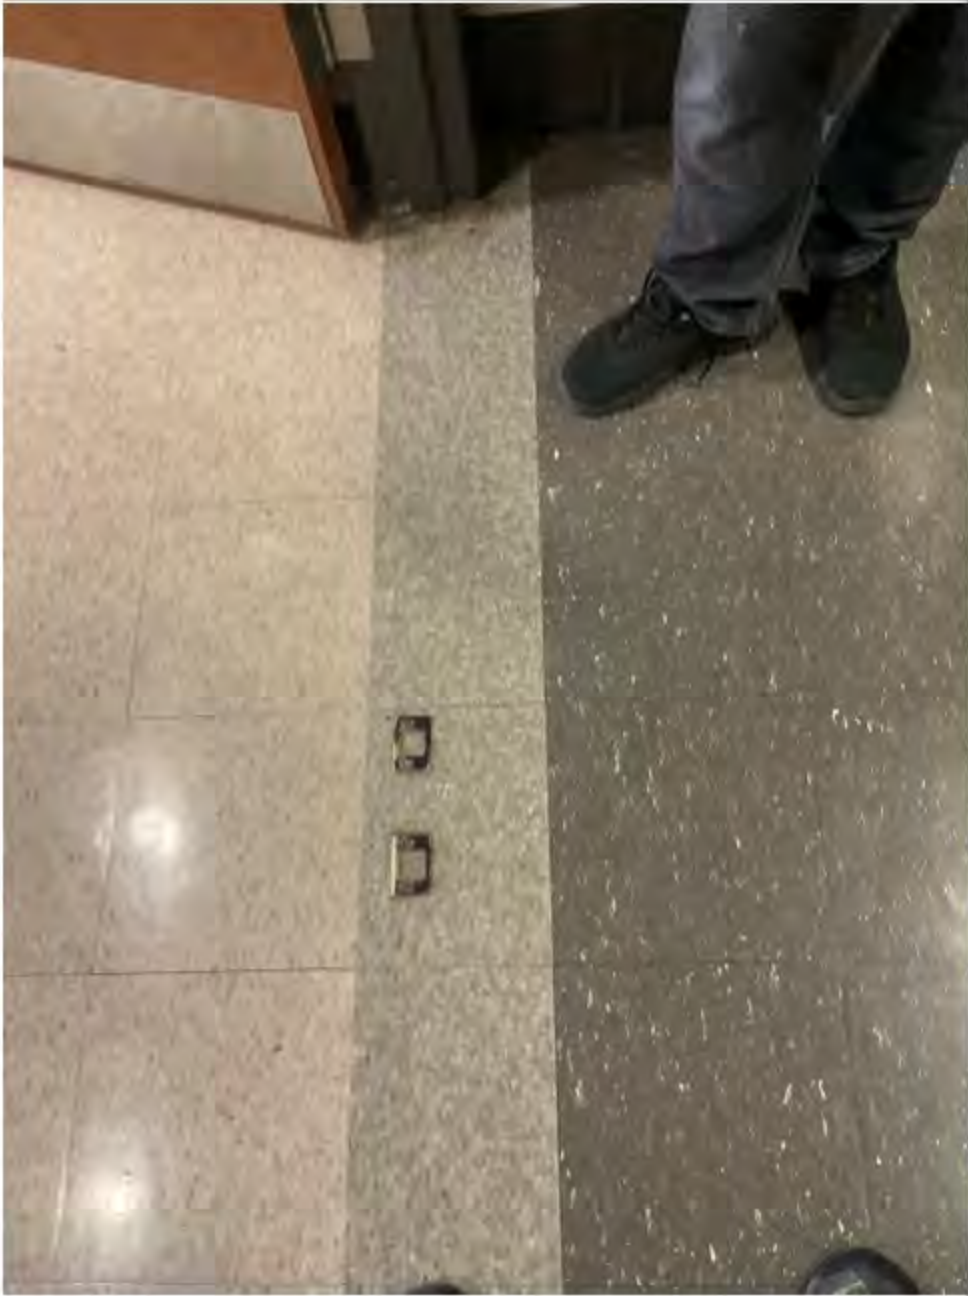
12x12 Heather Grey F.T.

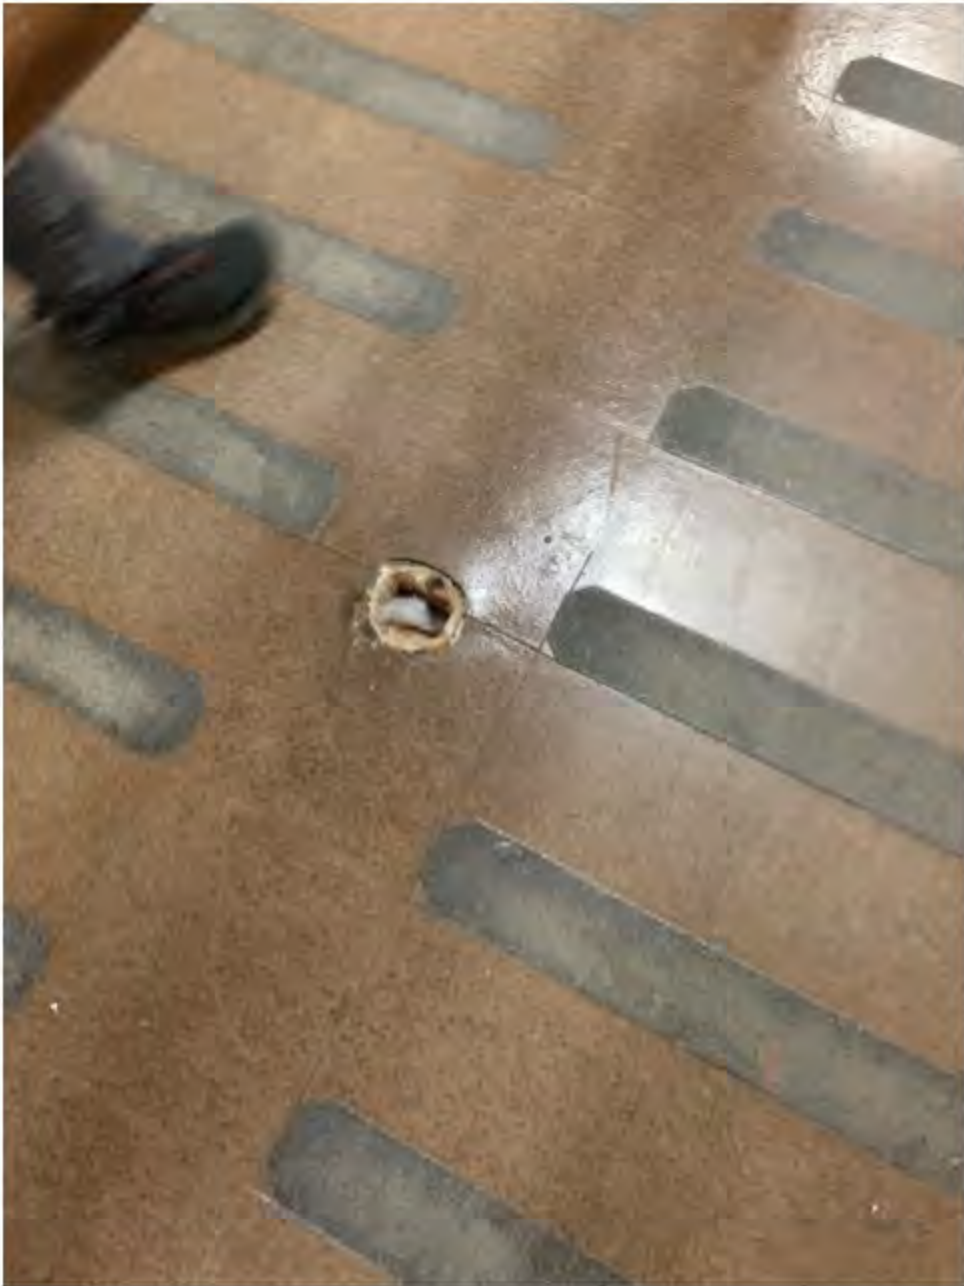
12x12 light brown F.T.

Quantity 7SF-Smart room entrance. 2000sf-hallways with railings/grip

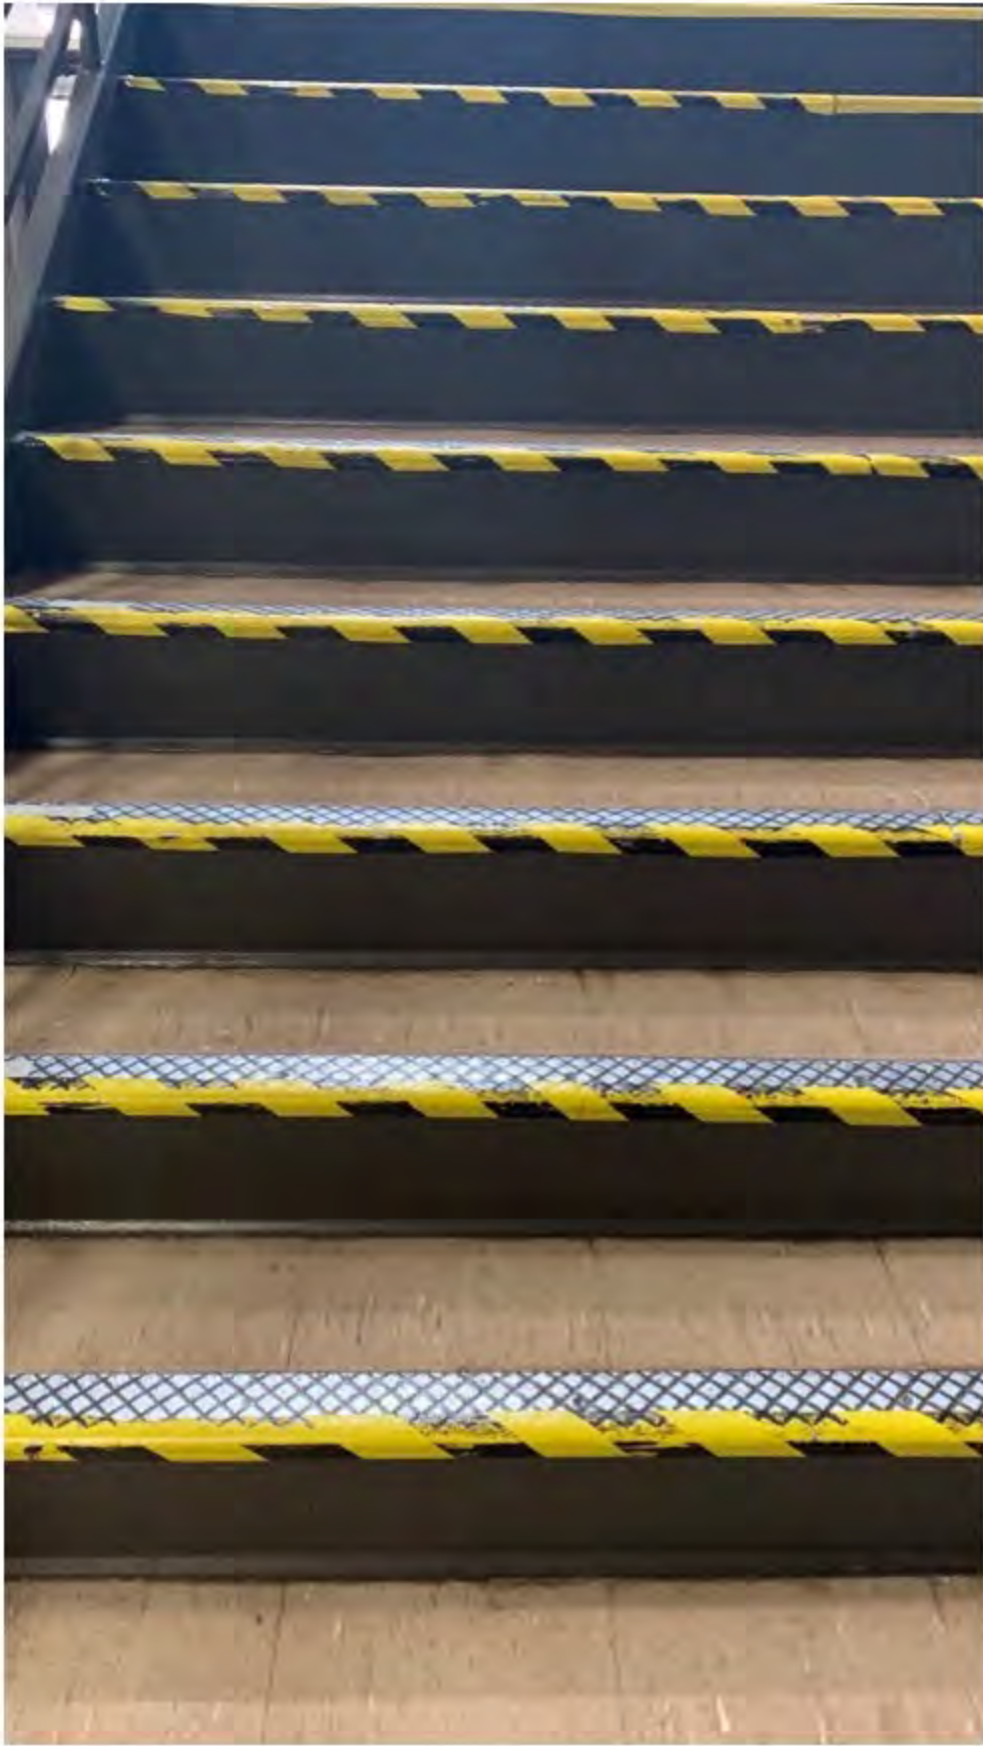
12x12 Light Brown Speck F.T.

Quantity 500sf-stairs near 151

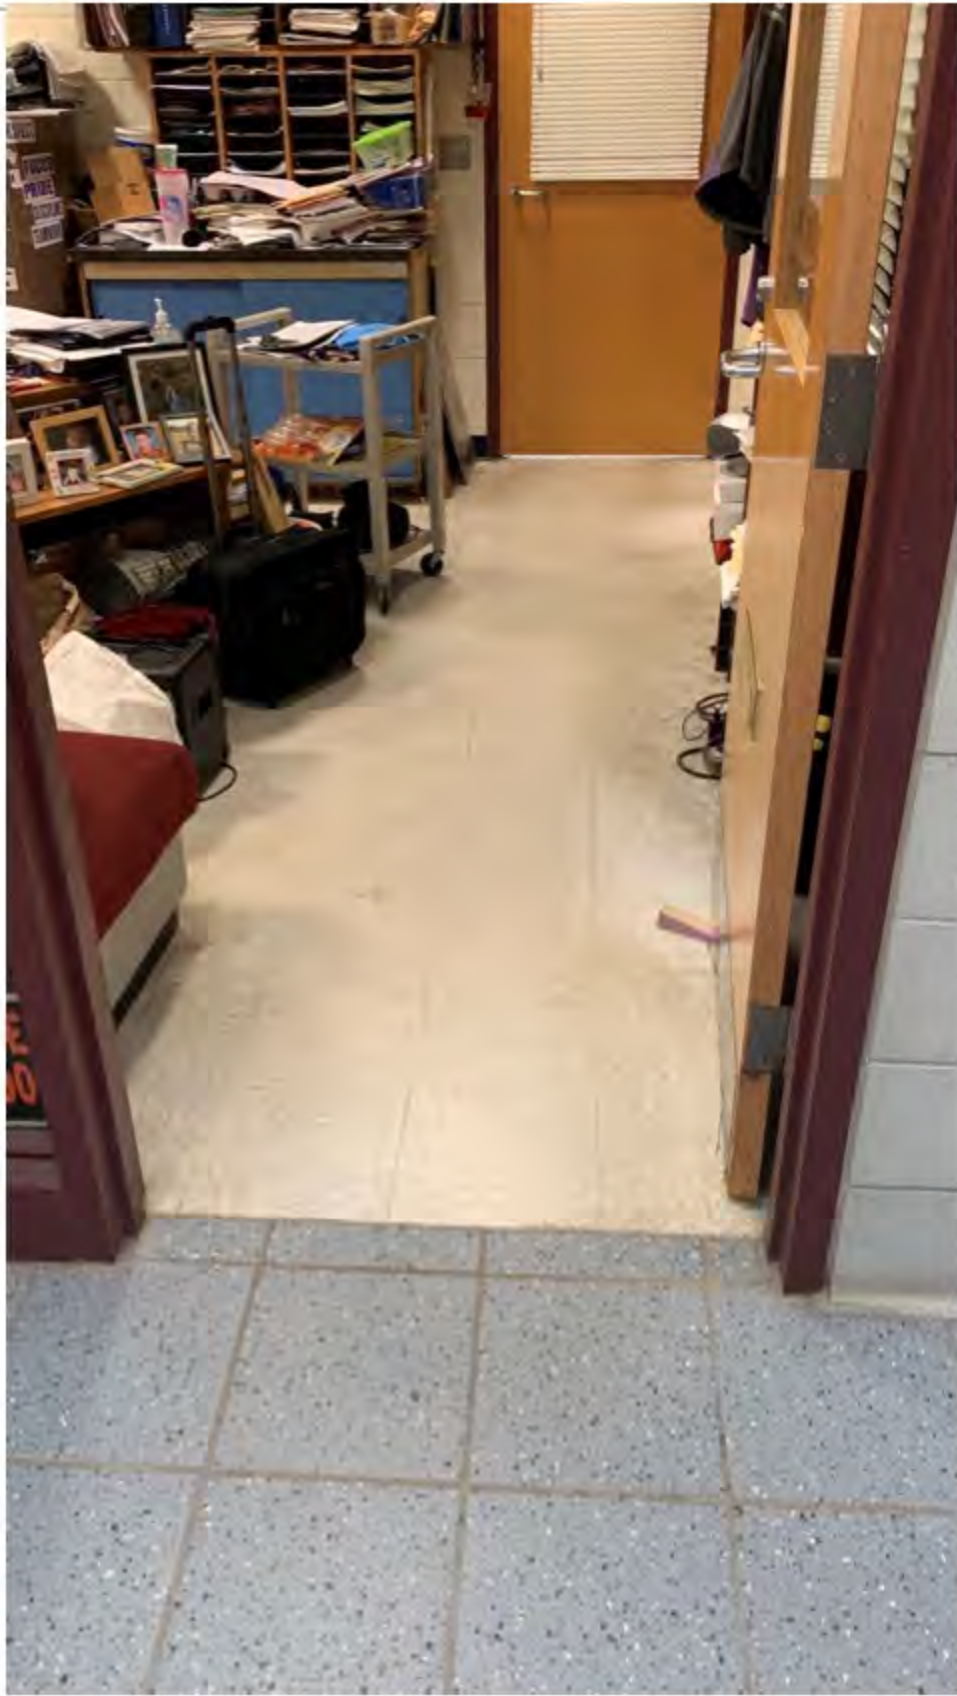
12x12 Light grey speck F.T.

50SF- outside 210. 225sf-Athletic Director 100Sf-girls locker room hall

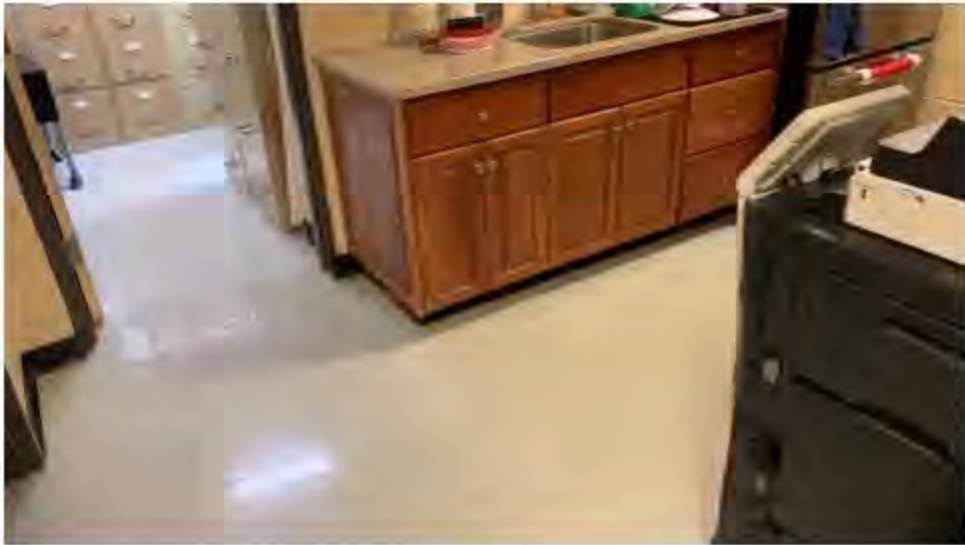
12x12 Mottled White FT

400SF-masonry building office

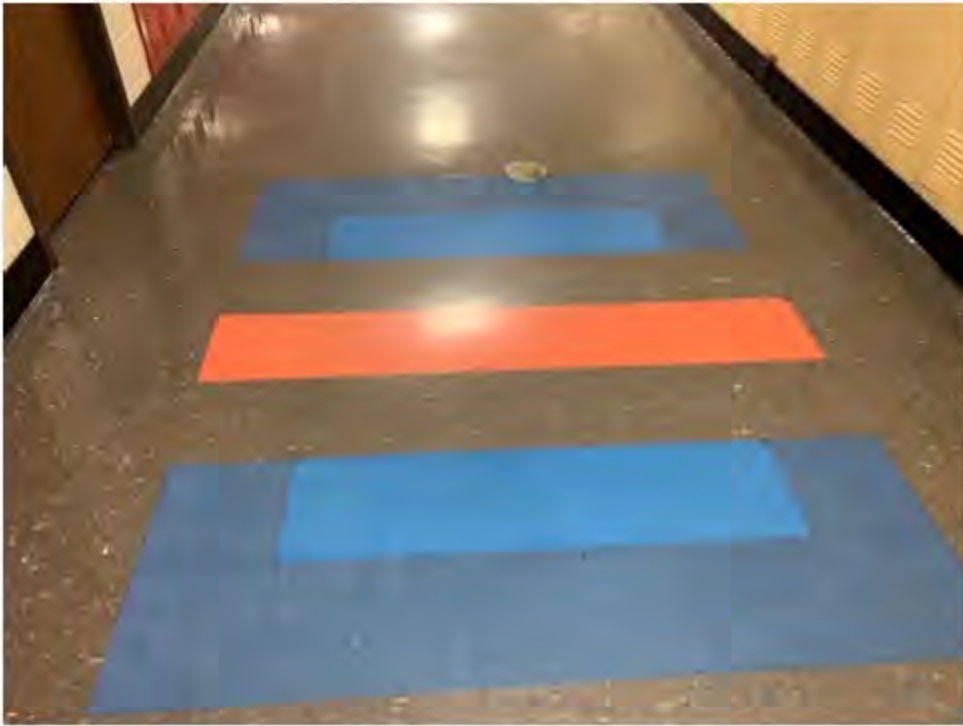
12x12 Orange F.T.

Quantity 100sf Throughout halls

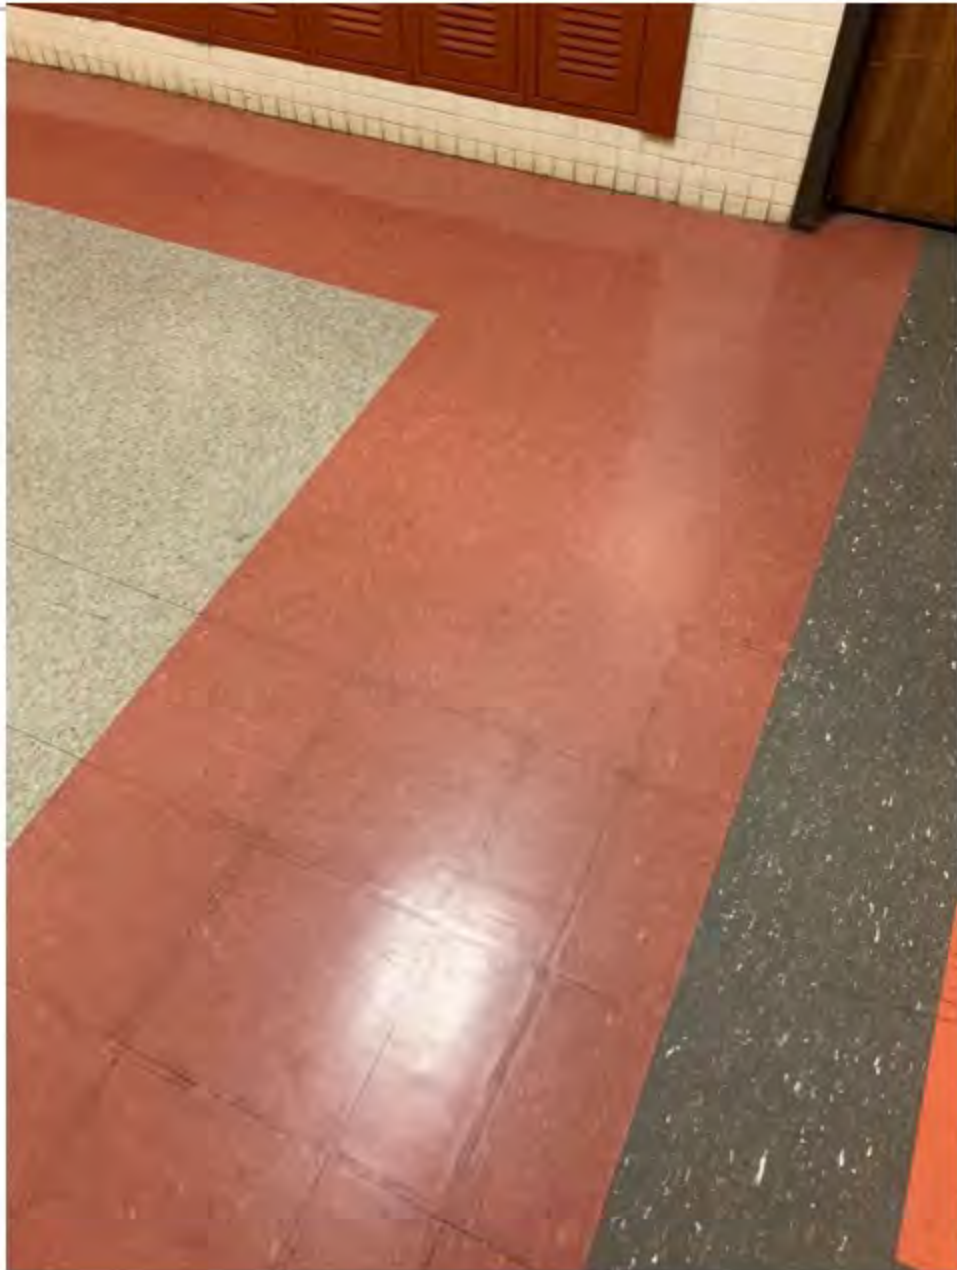
12x12 Orange Red F.T.

Quantity 1000sf -throughout hallways

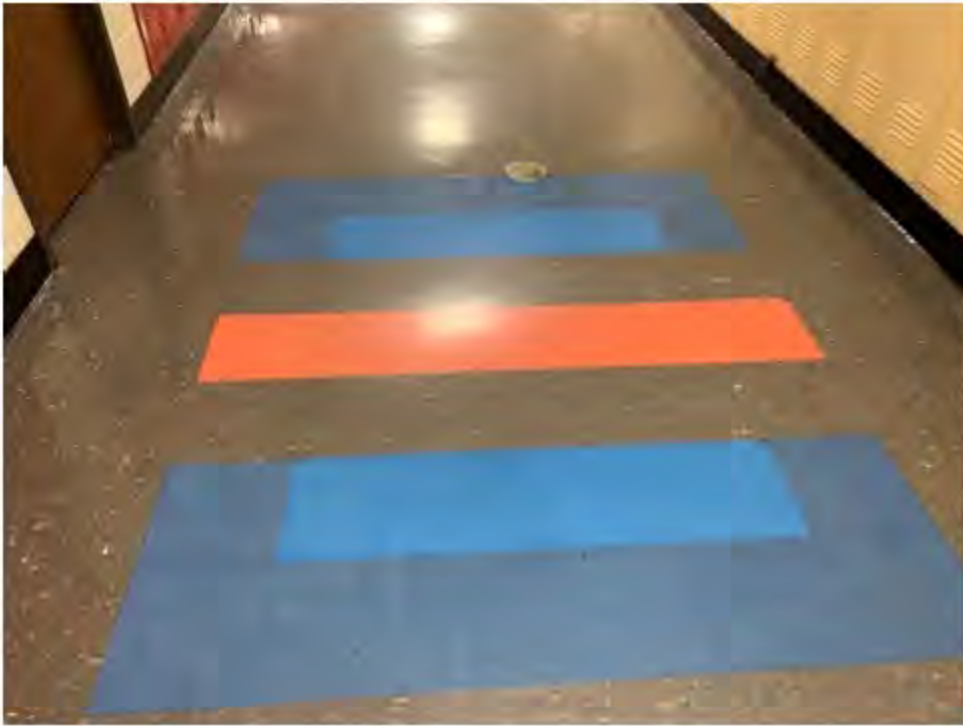
12x12 Royal Blue F.T.

Quantity 50 SF Thought out halls

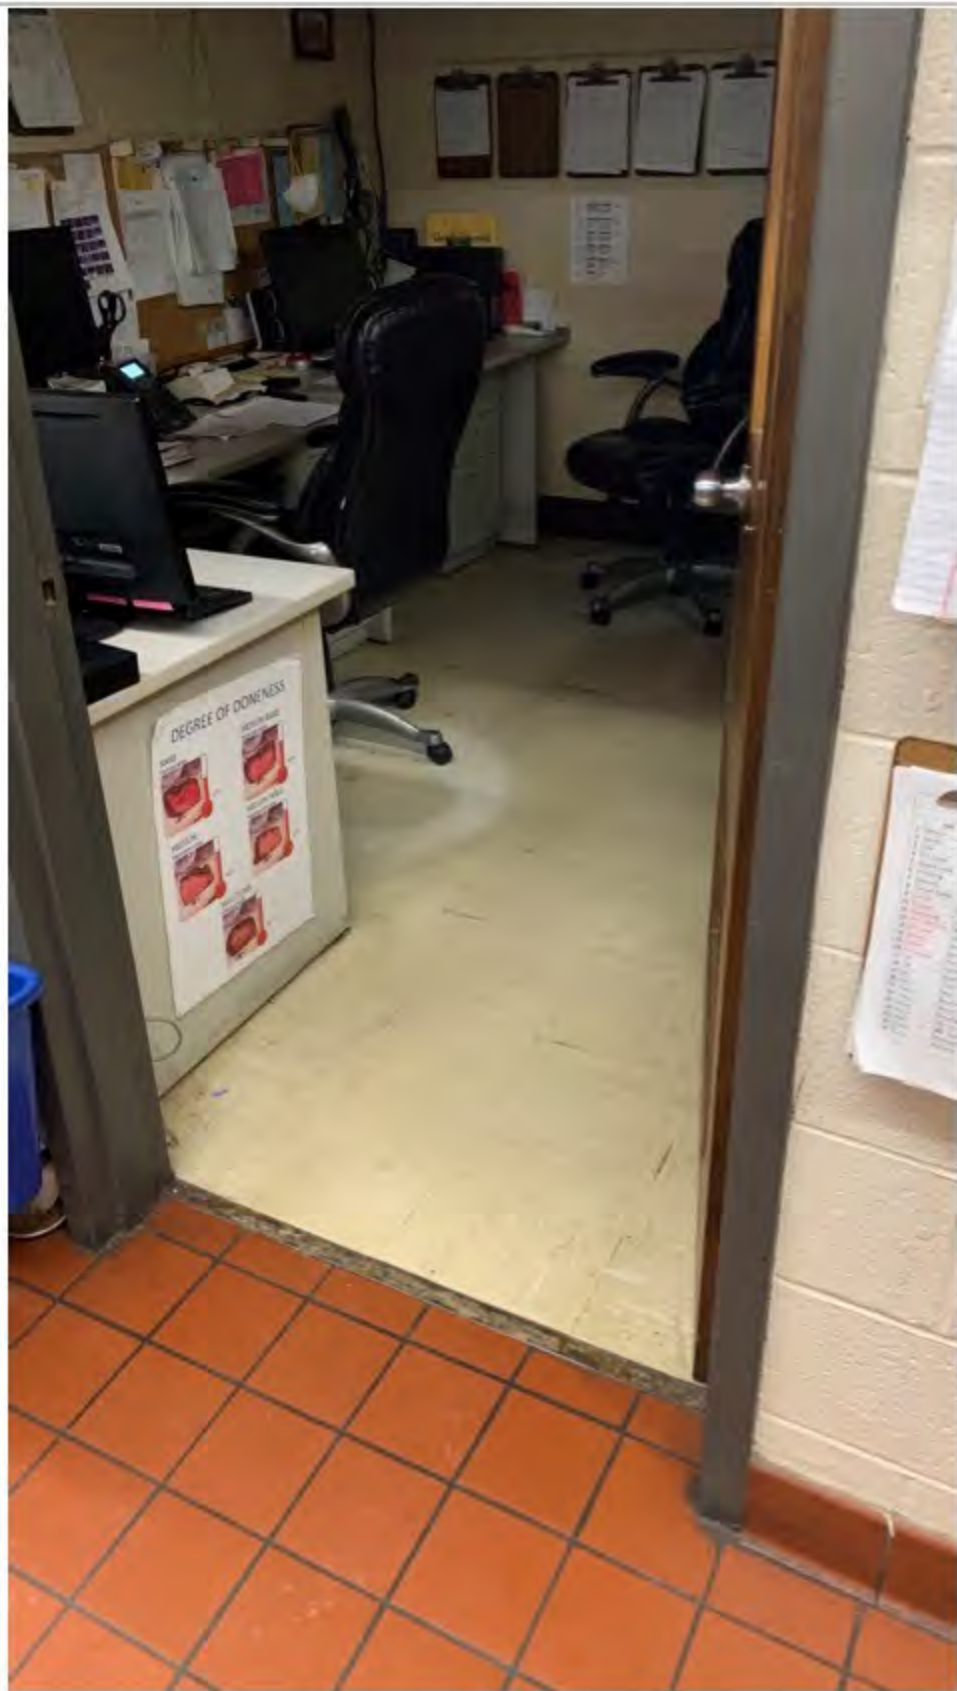
12x12 Tan FT
100sf- culinary arts office.

475sf-231 1500SF-business tech 569. 850SF-graphics comp room
850Sf-650

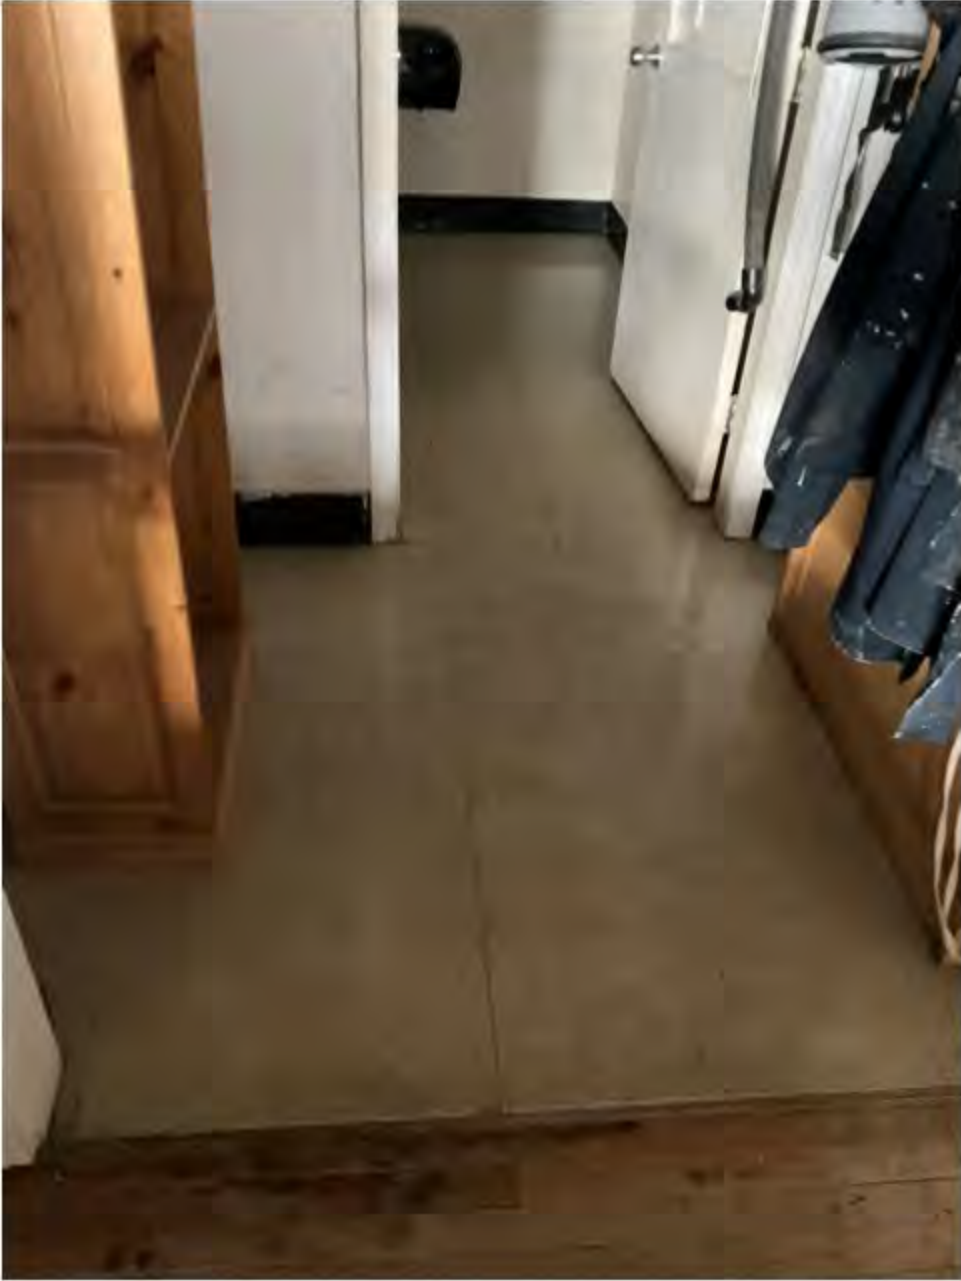
12x12 Tan Speck FT

75Sf-house carpentry bathroom

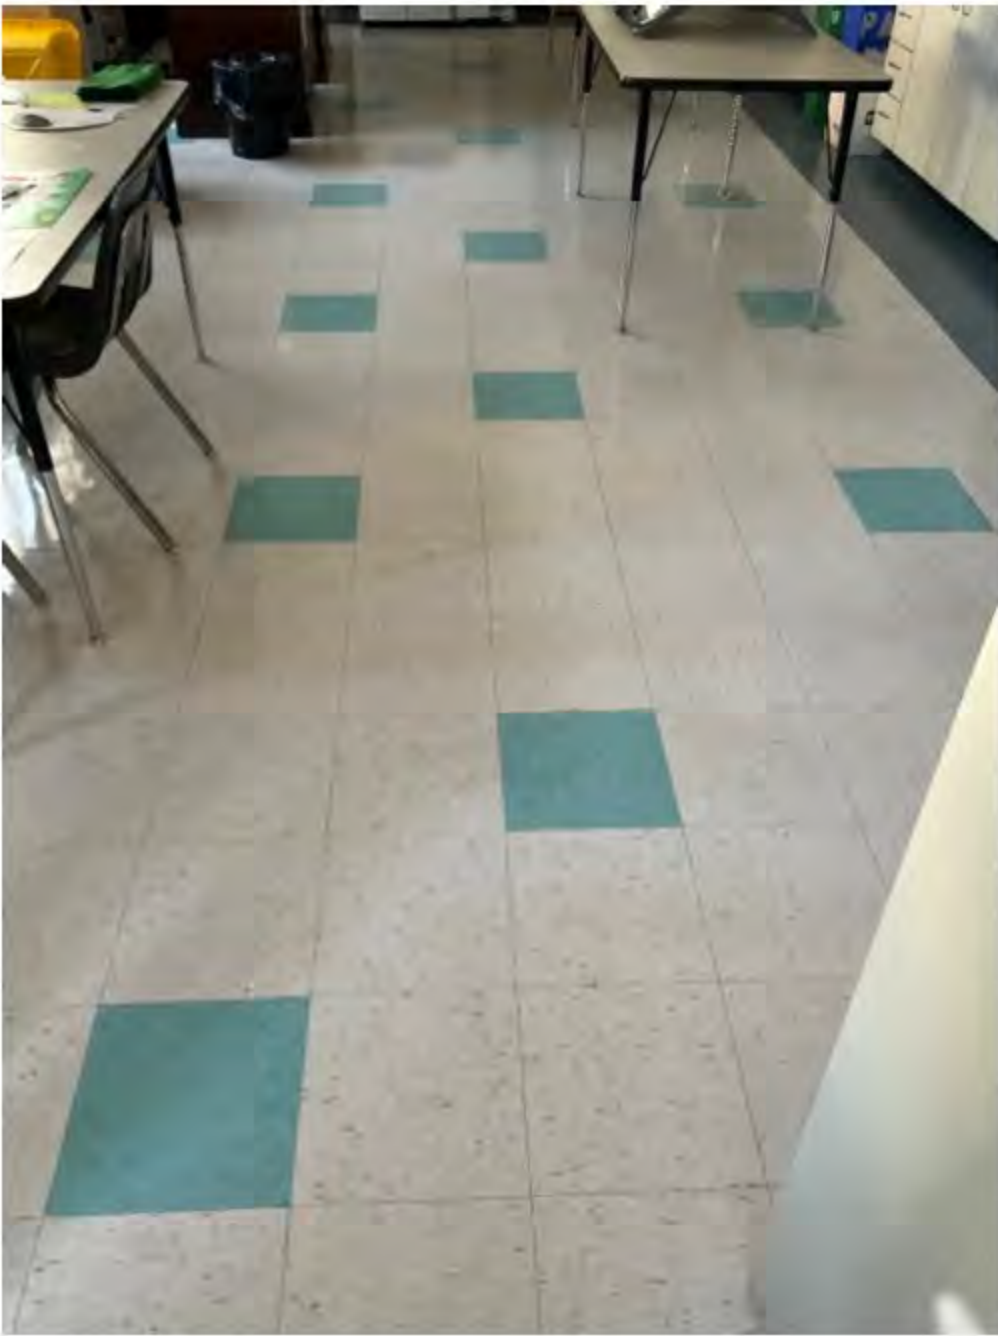
12x12 Turquoise FT

Quantity 44 SF-Early Childhood 137

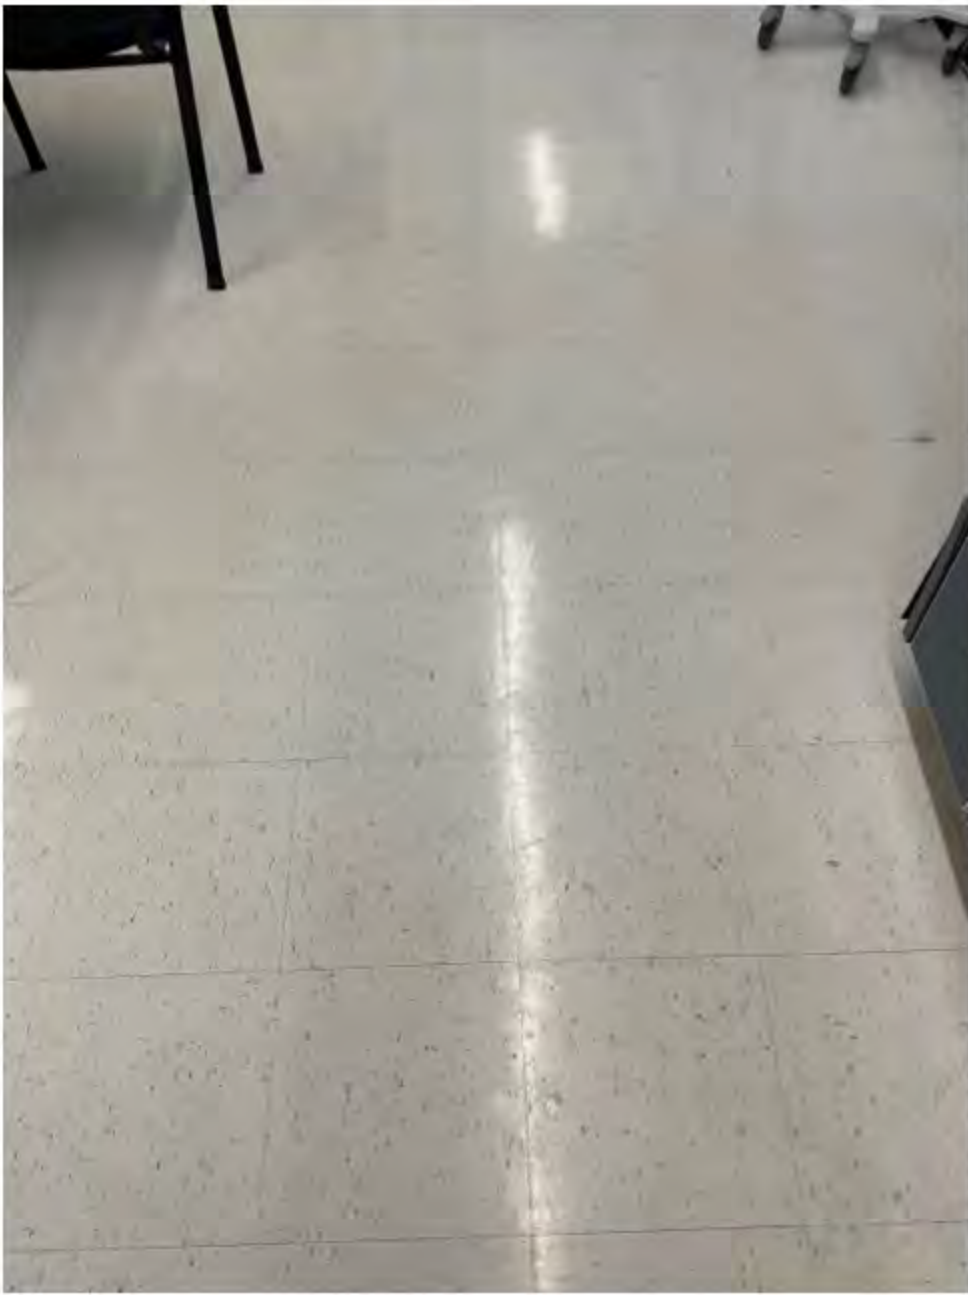
12x12 White with blue speck F.T.

Quantity 1000SF-Nurses Office 539
