AHERA 3-YEAR REINSPECTION REPORT

Montachusett Regional Vocational Technical School

1050 Westminster Street
Fitchburg, Massachusetts 01420

JANUARY 20, 2023

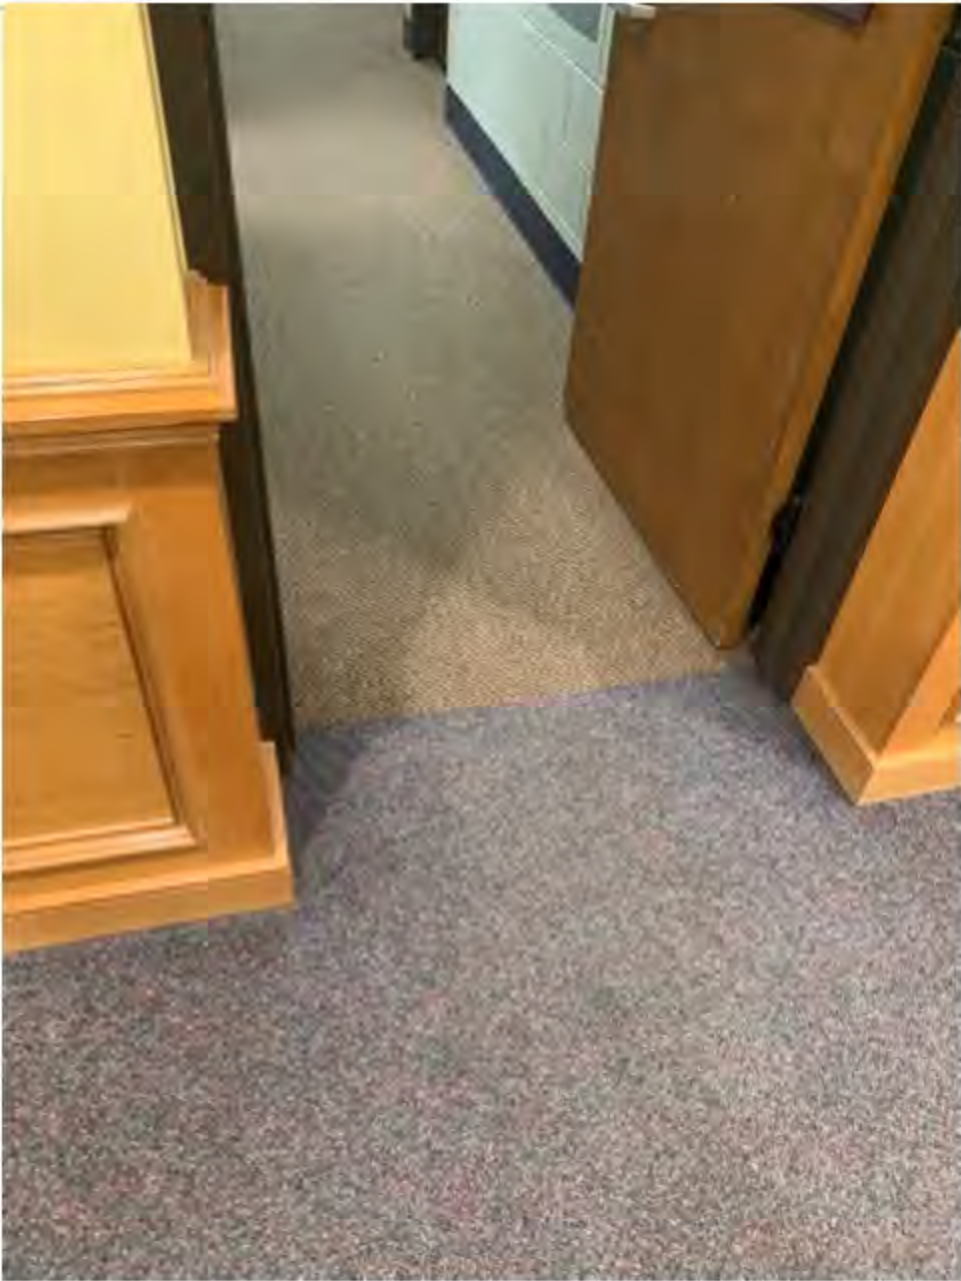
Blue carpet

500SF-main offices.

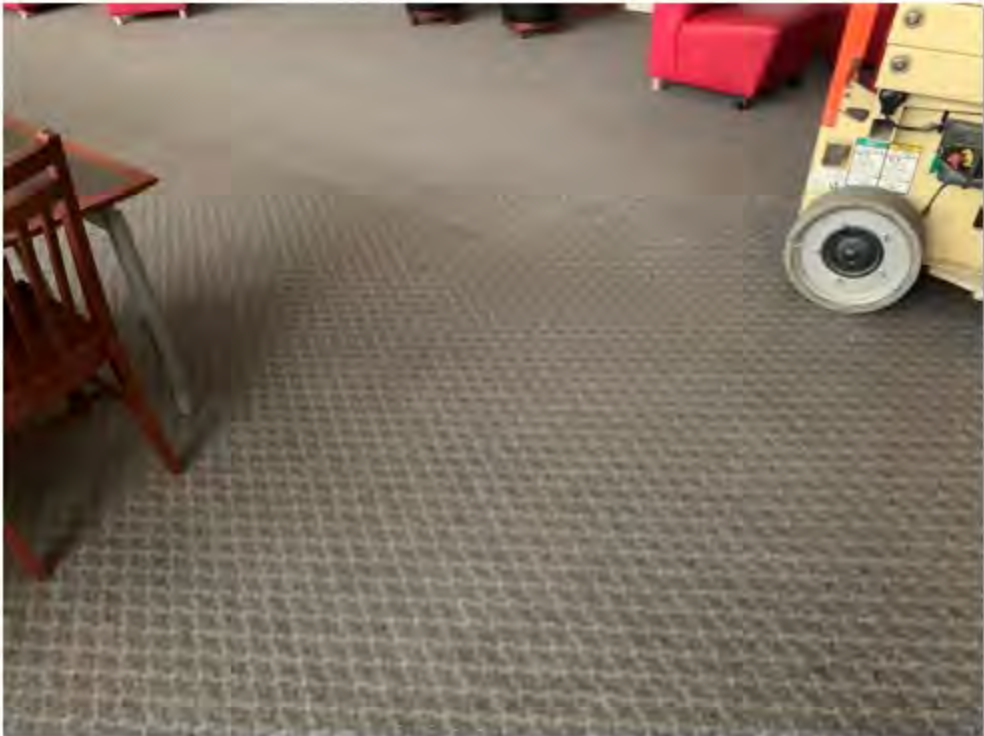
Grey carpet

Quantity 400SF-smart room. 2400SF-Library.

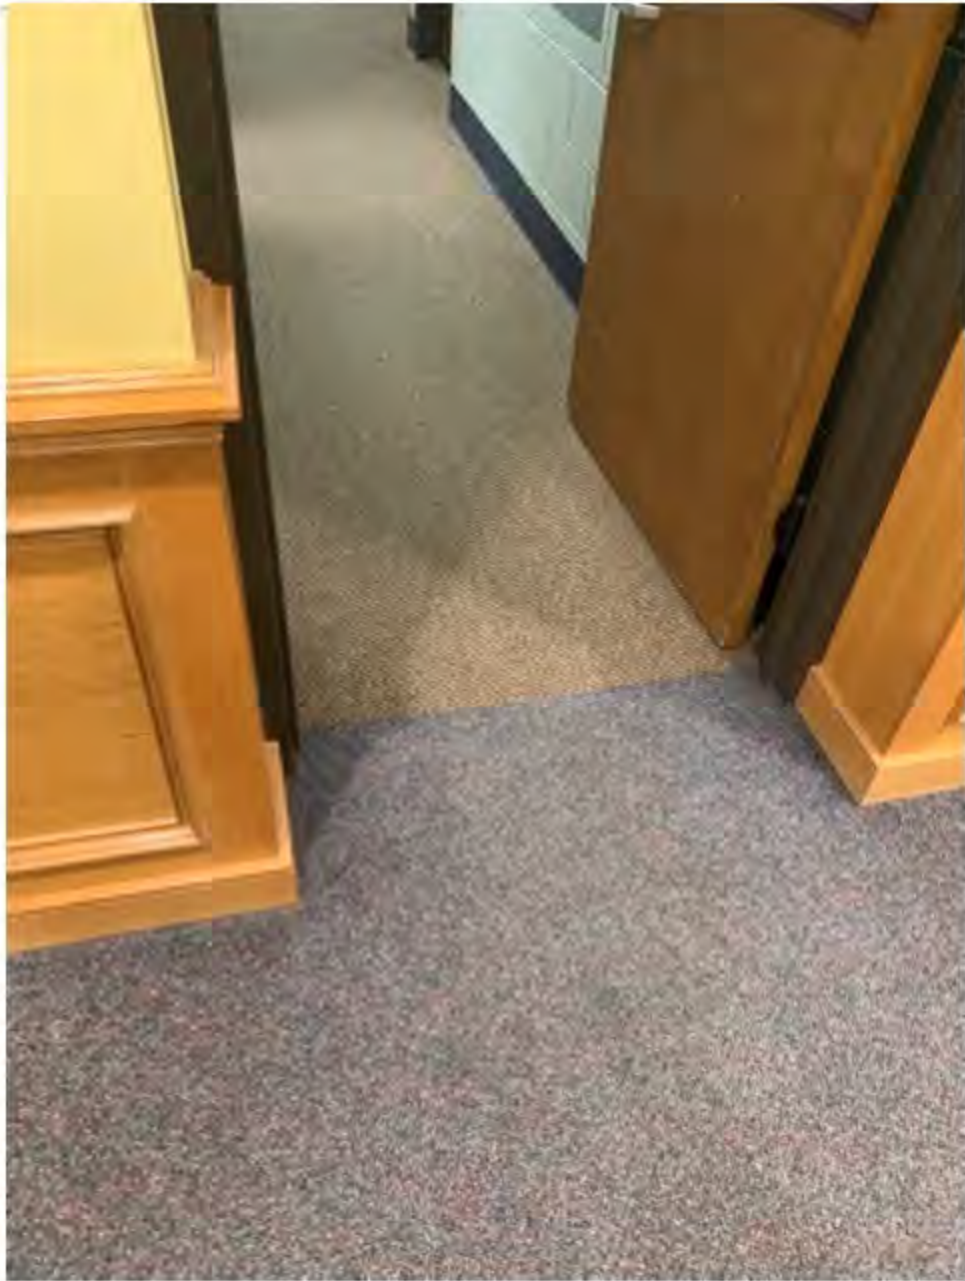
Tan carpet

2500SF-main offices. 2500SF-student support services

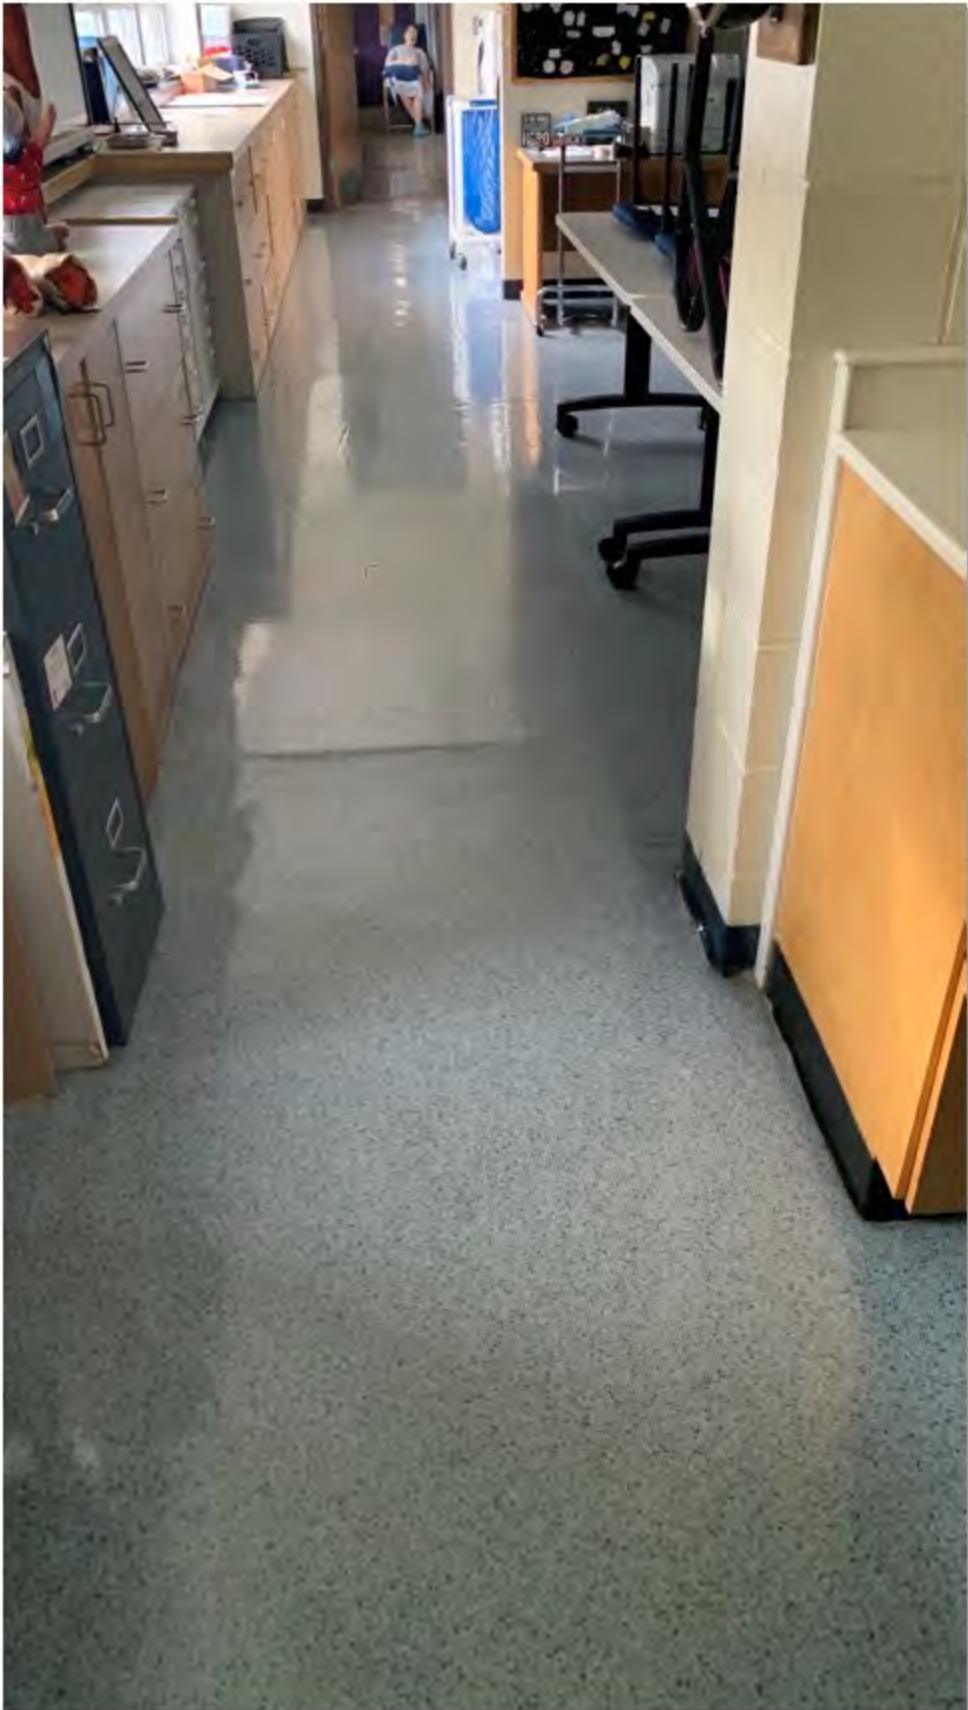
Blue Speck Sheet Flooring

Quantity 1220SF-Health 102

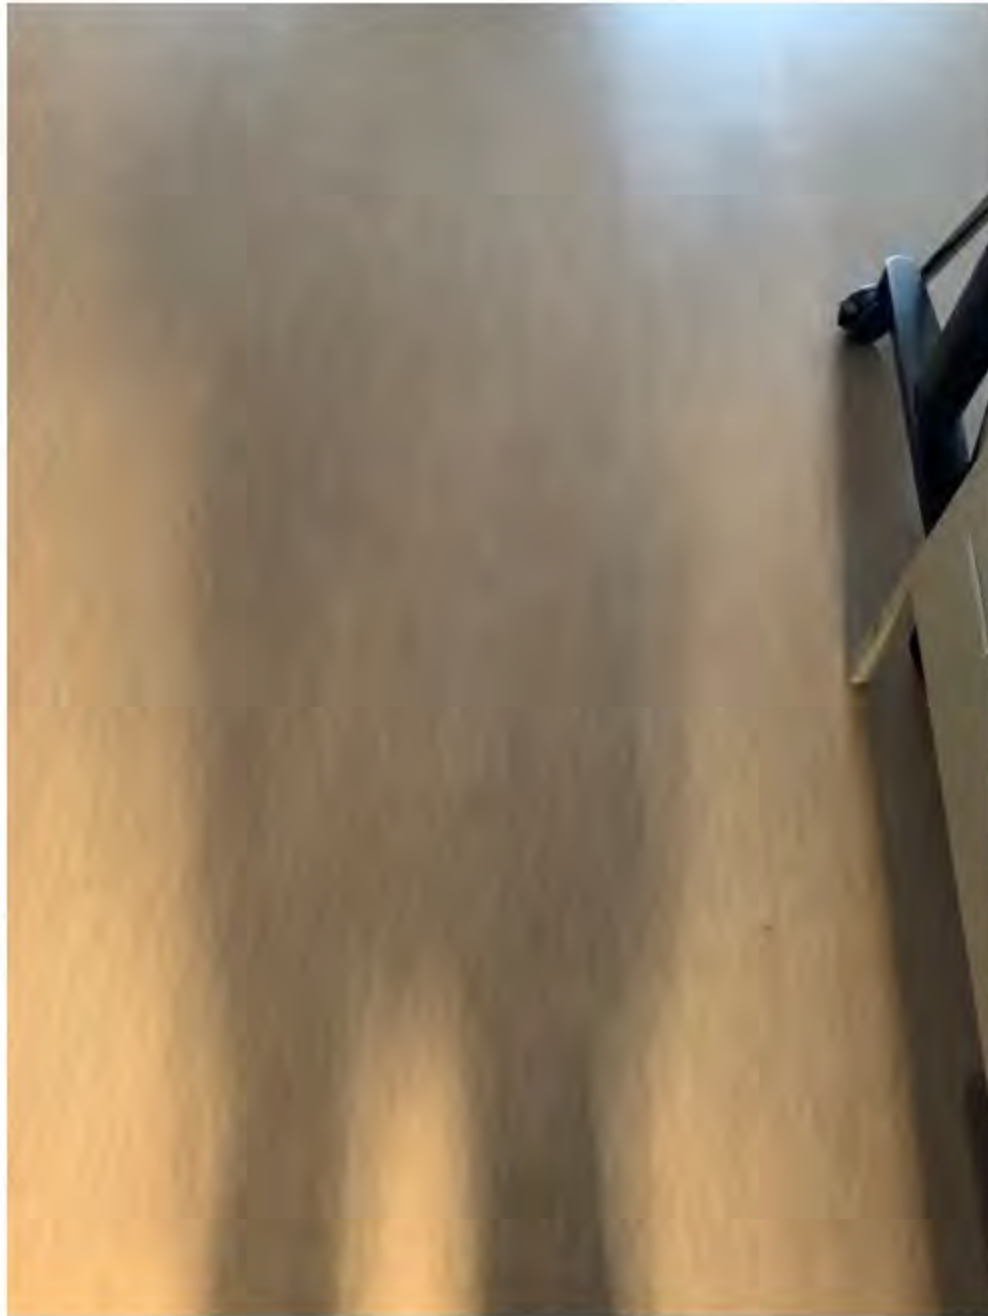
Faux Wood Sheet Flooring

Quantity 600SF-Director of tech. 2100SF-Dental assisting

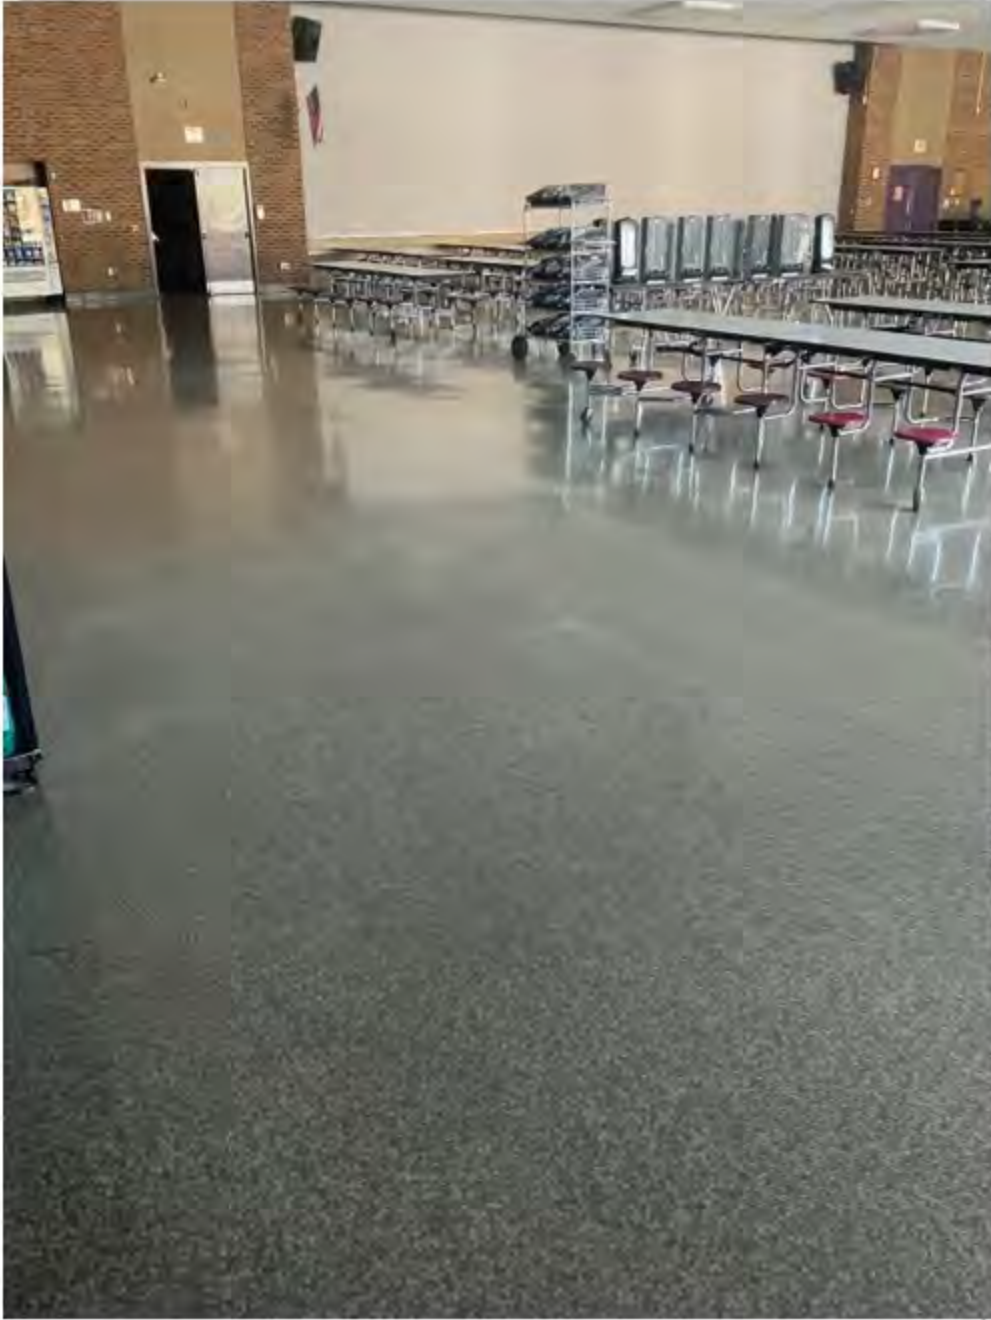
Grey pattern sheet flooring

Quantity 7000SF-cafeteria. 50SF-storage. 500sf-staff lounge

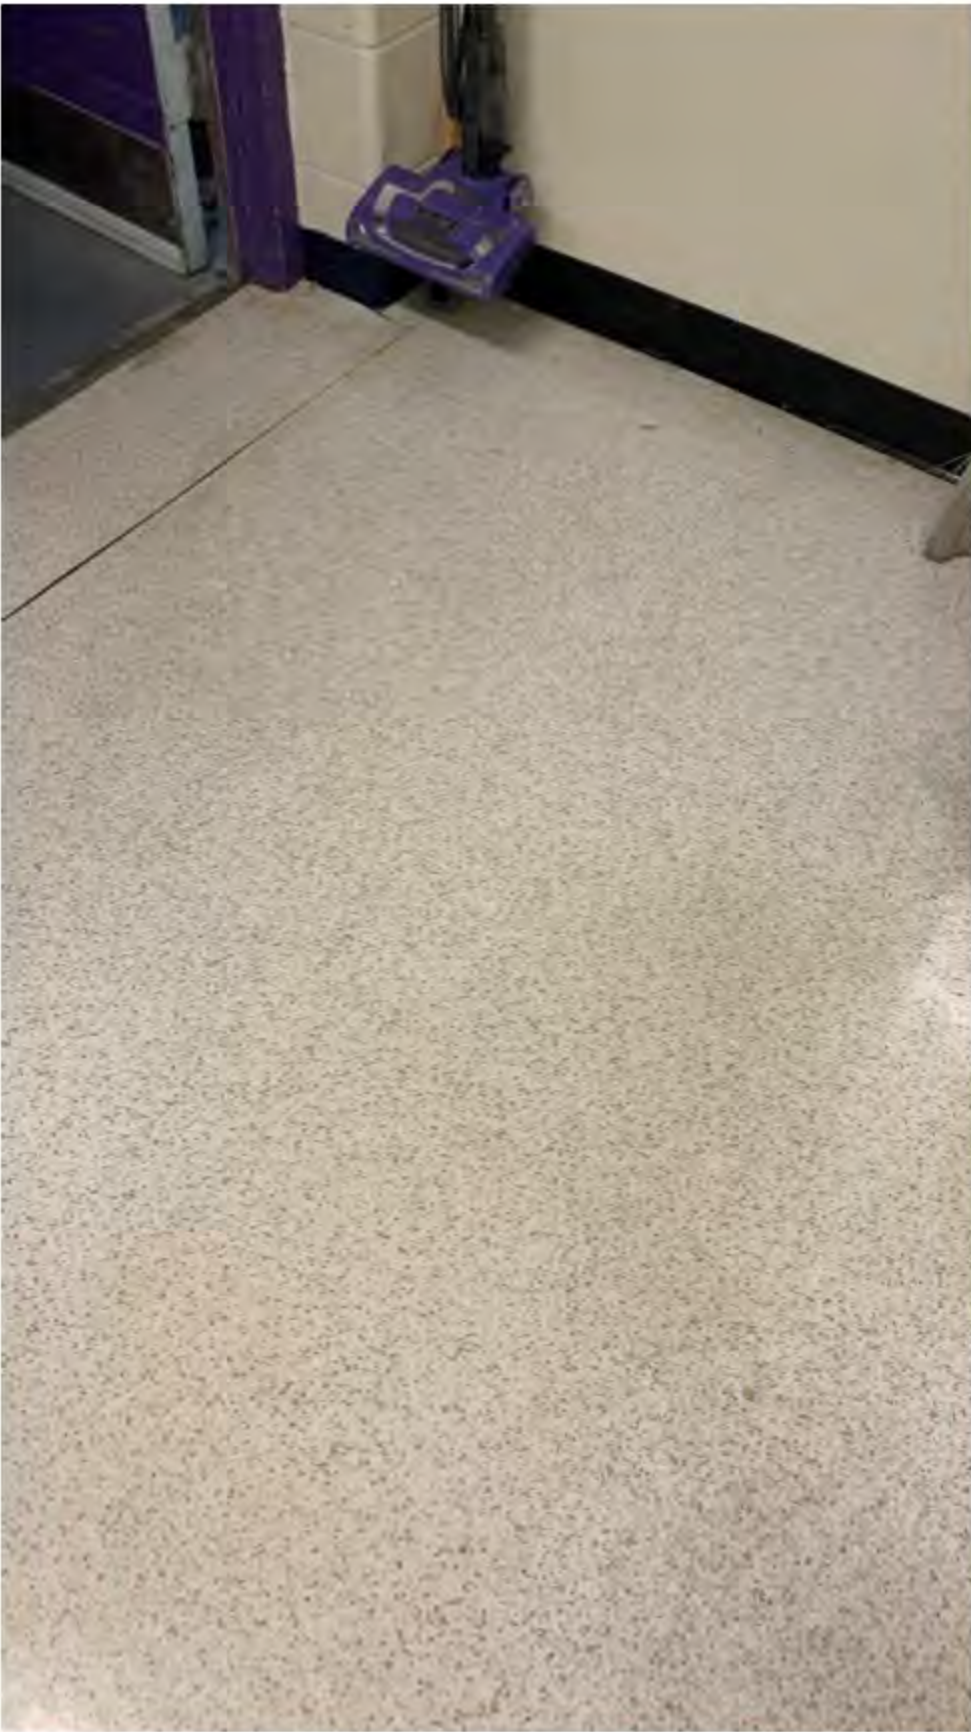
Tan Sheet Flooring

Quantity 180sf - Main Electrical Room

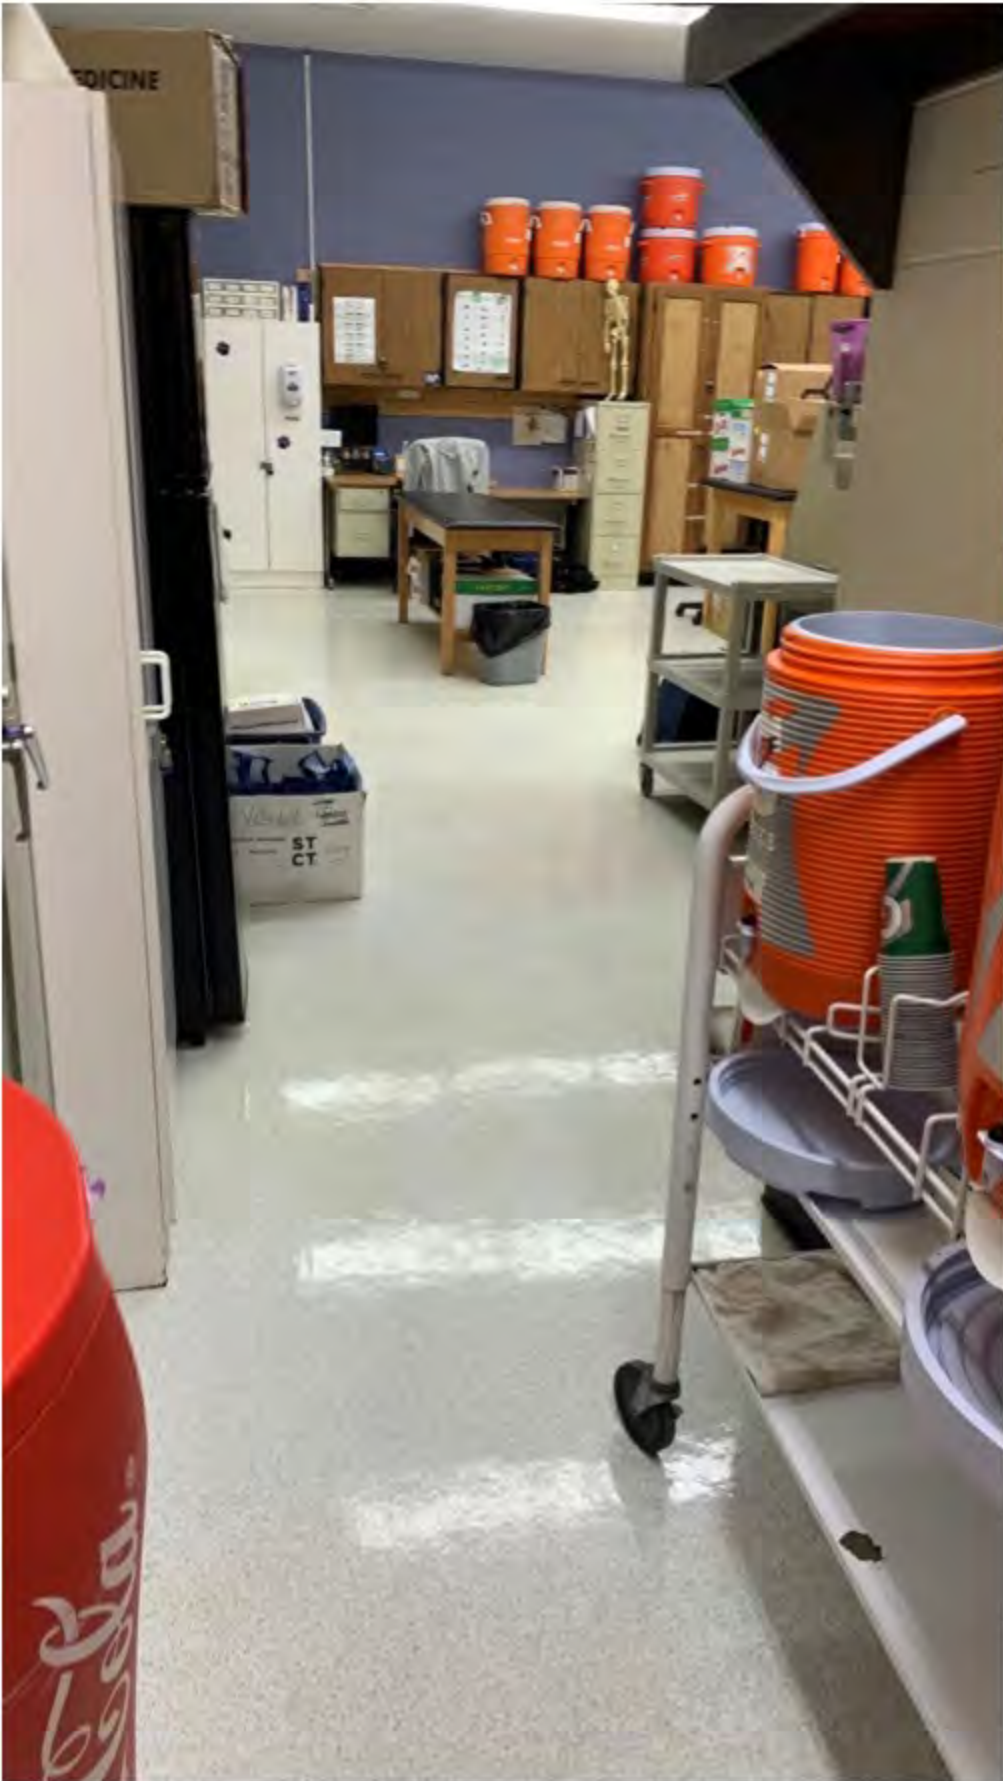
White Sheet Flooring

Quantity 1050sf-training room

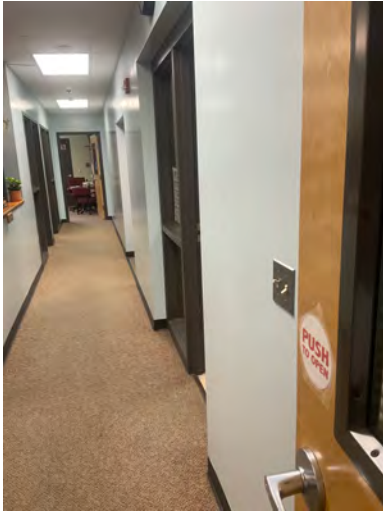
Wallboard and assoc. joint compound
414, 2000 SF
Auditorium 5000SF
Auditorium hall 1250
Auditorium lobby 1500
Courtyard classrooms floor 2 ceilings new build 8400SF
Library 1100SF
Sprague conference 700SF
330 IT, 480 sf
Superintendent office 600 sf
Director of tech. 1000SF
Occu. Health 102 1200SF
Occu health offices 600 SF
234, 1225 SF
231, 600SF
232, 600
234 1225sf
235, 1225sf
224, 200SF
Main office 200SF
Guidance 2500SF
Nurse hall maintenance 160SF
Staff lounge 300SF
731 900 SF ceiling
ROTC 200Sf
Graphic design 1000Sf
HVAC 320SF
New gym hall

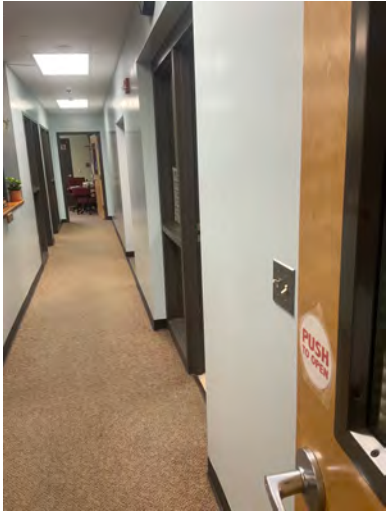
Wallboard and assoc. joint compound

Team room 300sf

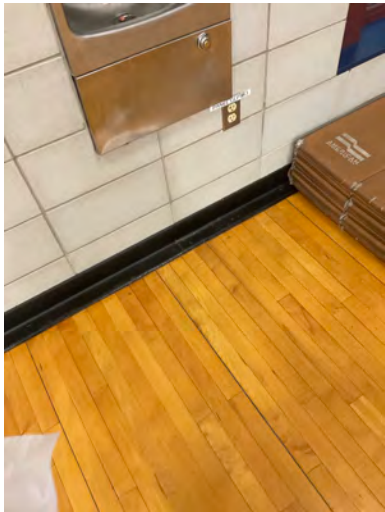
4" brown cove base and assoc. mastic

234, 140 LF

235, 140 LF

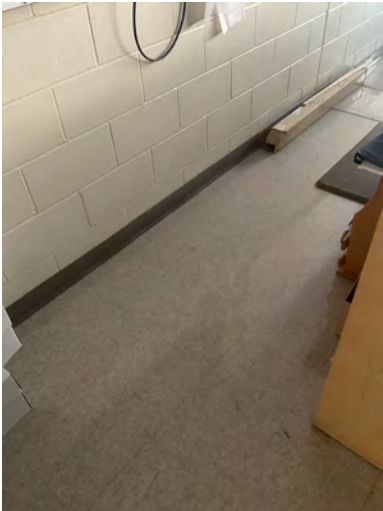
4" blue cove base and assoc. mastic

Occu health 102, 90 lf

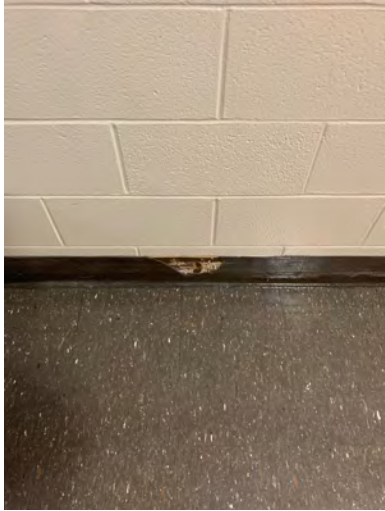
5" dark brown cove base and assoc. mastic

150 LF culinary arts hall

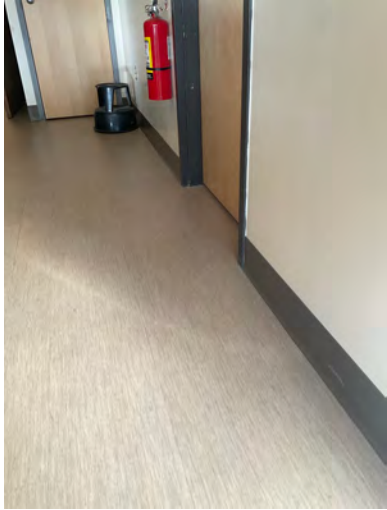
6" brown cove base and assoc. mastic

Dental assistant, 320LF

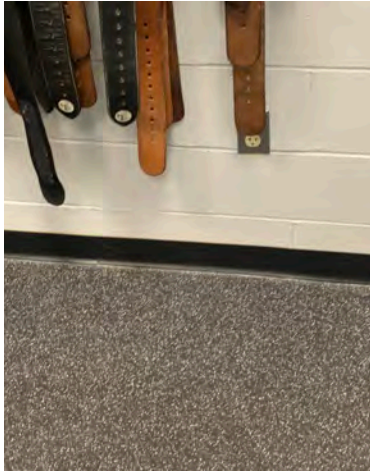
4" black cove base and mastic
Location
236, 120lf
80lf, green rooms
Backstage access 30LF
940, 100LF
4 Auditorium hall closets, 30 each, 120 total
4 auditorium stairs 80 of per 320LF
Courtyard classrooms floor 2 new build, 1400LF
Courtyard classrooms floor 2 old build 1400LF
Superintendent office, 30LF
Director of tech closet 40lf
Early childhood 127, 100sf
Guidance 250LF
Nurse bath 40LF
525 110 LF
731 120 LF
730 120LF
725 120 LF
Business tech 200LF
Culinary arts classroom 120Lf
Graphic design computer room 110LF
Yoga room, 120LF
HVAC 40lf
Weight room 120LF
Training room 150LF
619, 120 LF
671 120SF

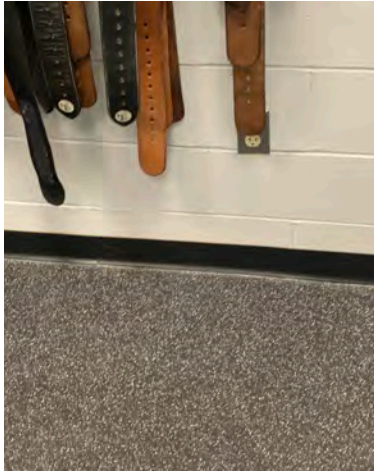
4" black cove base and mastic

501, 120Lf

502, 120 LF

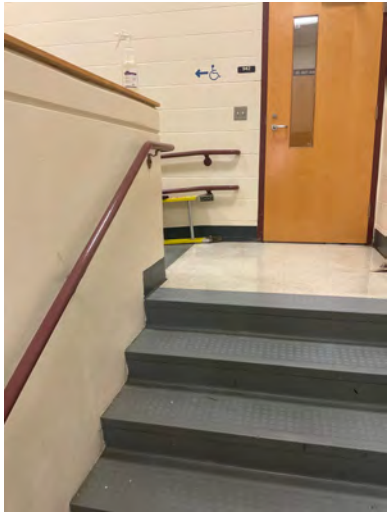
6" black cove base and mastic

Backstage, 200lf
330 IT 210 LF

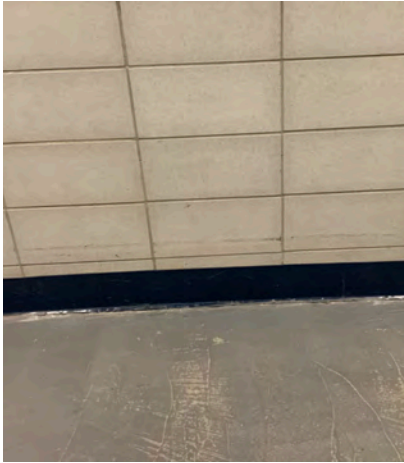
5" blue cove base and mastic

Main office 300LF

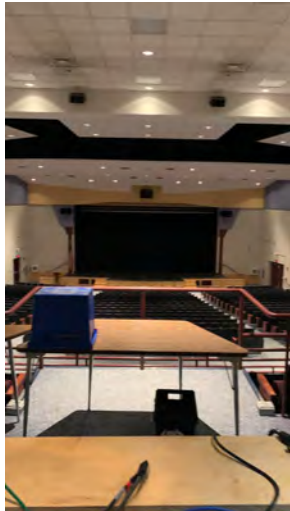
2'x2' Rough pattern, mixed cellulose suspended ceiling tile

3600 sf tea room

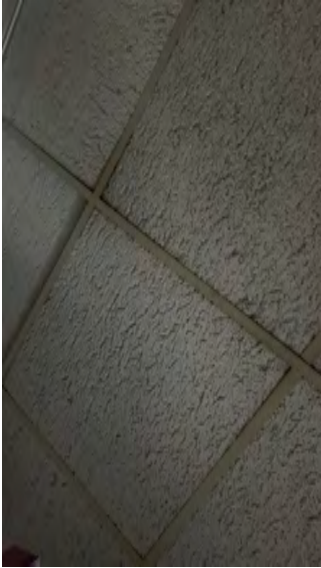
2'x 2' dent and fissure mixed cellulose suspended ceiling tile

Cafe storage back room, 500SF

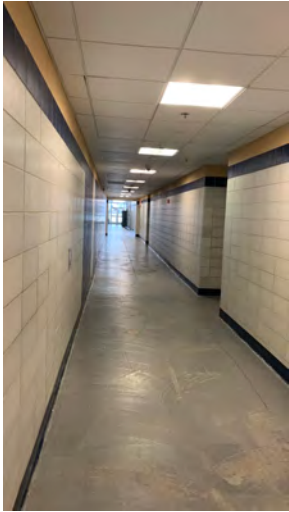
2'x2' dot pattern mixed cellulose suspended ceiling tile

Maintenance hall 2500sf

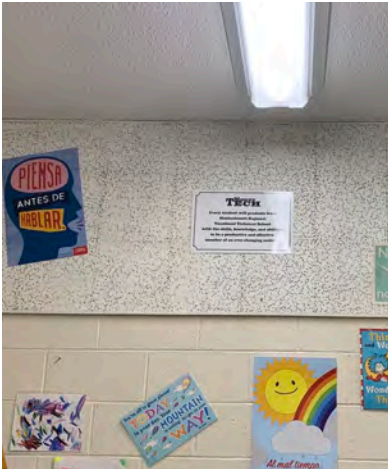
1'x1' wall tile and associated glue daubs

Early childhood 127 200SF
222, 140 Sf

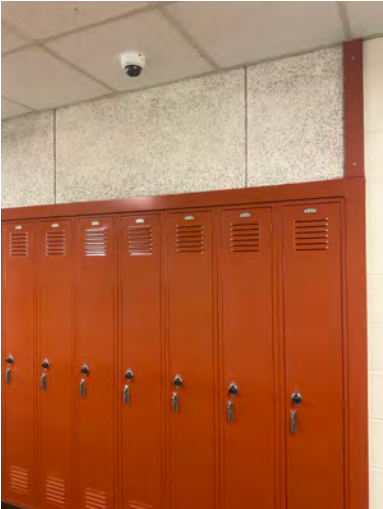
Acoustical wall panels in halls

Maintenance hall 100sf
Courtyard hall 2450 sf

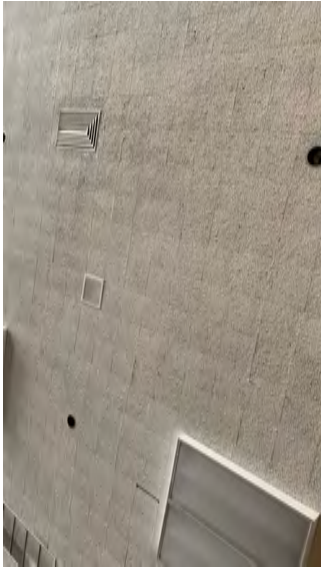
1'x1' Ceiling tile and associated glue daubs

Cafe 7000sf

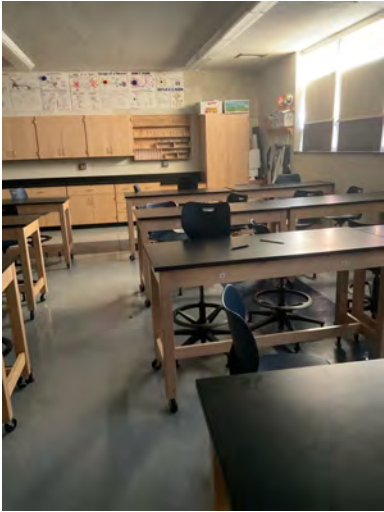
Lab benches

Room 534 12 benches

Room 524 22 benches

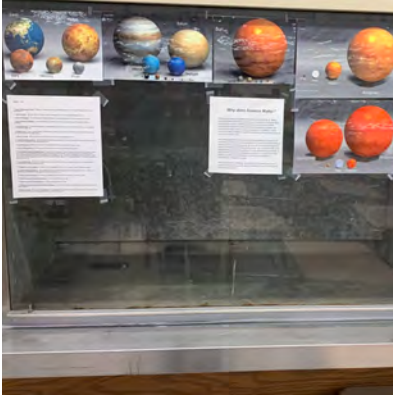
Transite Fume Hood Panel

Room 534

40 SF

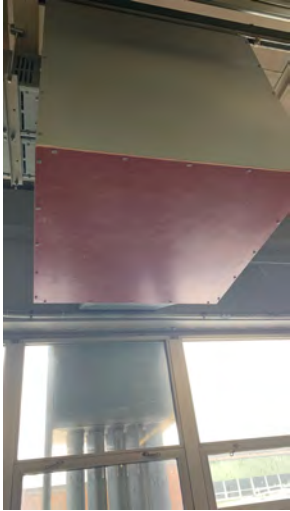
Electrical Conduit Panel

Main electrical room, on conduit duct

4 Sf

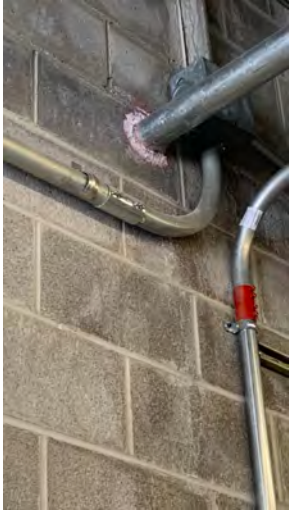
Fire stop sealant

Main electrical room, on pipe penetration

2 sf

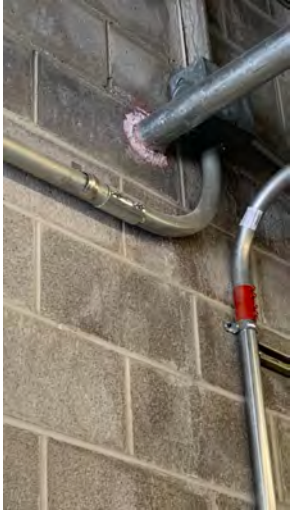
Fire stop sealant

Main electrical room, on pipe penetration

2 sf

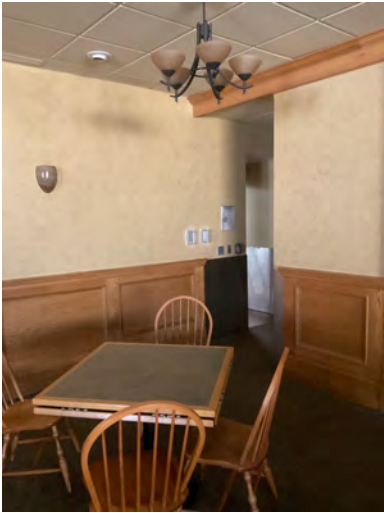
Plaster walls and ceilings

2000 tea room

5000 cafe

15,000 1970 hallway walls

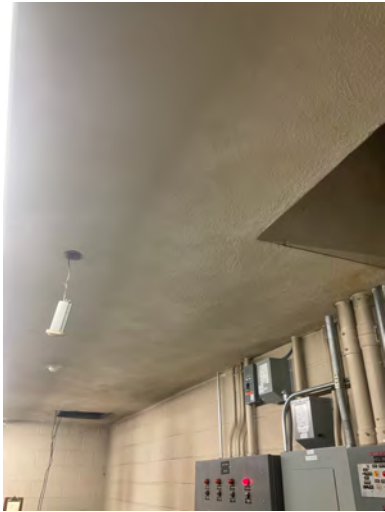
Tan plaster textured ceiling

Automotive electrical closet, 200SF

Graphic design electrical room 400Sf

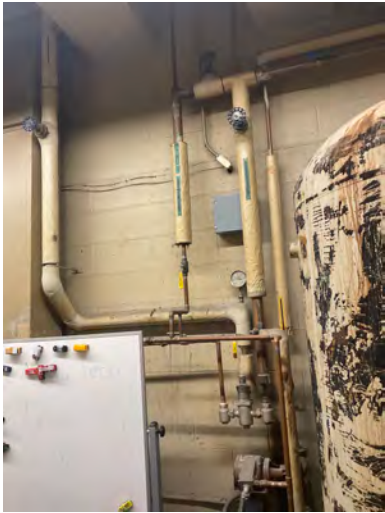
LOCATION	MATERIAL	FRIABLE	CONDITION
Shipping and Receiving	Damaged Pipe Fitting in Caged Area	Friable	Damaged
Sprinkler Room	12"x 12" Bluish-Grey VFT and associated Mastic	Not Friable	Damaged
Sprinkler Room	Joint Compound and associated Wallboard	Friable	Damaged

Muddled Elbows and Fittings

Shipping and receiving, 1 Fitting

- Abate or Encapsulate damaged pipe fitting in shipping and receiving
- Engage a properly licensed Massachusetts Asbestos Inspector to determine whether the damaged and buckling 12"x 12" Bluish-Grey VFT and associated Mastic contain asbestos. IF these materials are determined to contain asbestos, engage a properly licensed Massachusetts Asbestos Contractor to abate the material following all local and federal asbestos regulations.
- Engage a properly licensed Massachusetts Asbestos Inspector to determine whether the damaged Joint Compound and associated Wallboard contain asbestos. If these materials are determined to contain asbestos, engage a properly licensed Massachusetts Asbestos Contractor to abate the material following all local and federal asbestos regulations.
